# Access Compliance Report

## Public Rights-of-Way

### (Curb Ramps)

Intersection ID: 47457	Main Street: STEELE_CREEK_RD	Cross Street: WINGED_TEAL_RD	Location: SE
ADA ID: C298CE873CB0	Ramp Type: Perp	Initial Pass/Fail: Fail	Overall Compliance: No
Severity Score: 46.25			
Codes/Mitigation Info/Possible Solution		Field Measurements/Component Compliance

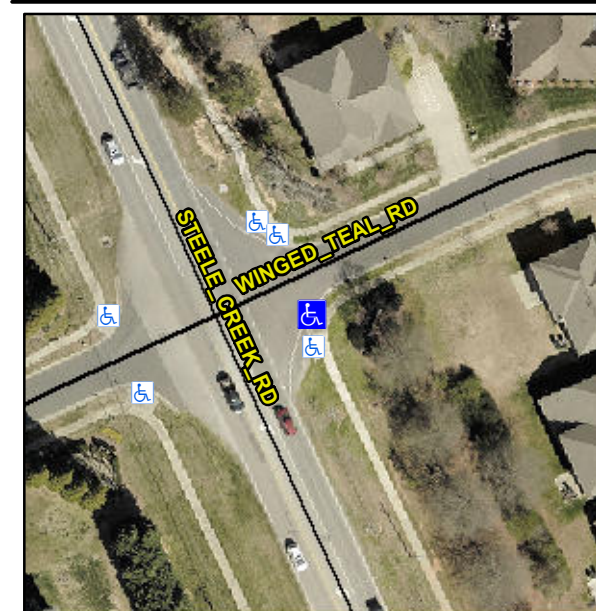
Compliance	Description	Data	Compliance	Description	Data
N/A	Ramp Length (in)	54.0	No	Ramp Slope (%)	8.4
No	Ramp Width (in)	47.0	No	Ramp XSlope (%)	8.1
N/A	Flare Type LT	N/A	N/A	Flare Type RT	N/A
N/A	Flare Slope LT (%)	N/A	N/A	Flare Slope RT (%)	N/A
N/A	Flare Traversable LT?	N/A	N/A	Flare Traversable RT?	N/A
N/A	Landing Length (in)	N/A	N/A	DWS Provided?	N/A
N/A	Landing Width (in)	N/A	N/A	DWS Contrast?	N/A
N/A	Landing Slope (%)	N/A	N/A	DWS Length (in)	N/A
N/A	Landing X Slope (%)	N/A	N/A	DWS Full Width?	N/A
N/A	Landing Curb? (Y/N)	N/A	N/A	DWS Offset (in)	N/A
N/A	Shared Landing?	N/A			
N/A	Gutter Ponding?	N/A	N/A	Gutter Slope (%)	N/A
N/A	Gutter Lip Ht (in)	N/A	N/A	Gutter X Slope (%)	N/A
N/A	Painted X Walk1?	No	N/A	Painted X Walk2?	N/A
	X Walk 1 Direction	To N		X Walk 2 Direction	N/A
N/A	X Walk 1 Width (in)	N/A	N/A	X Walk 2 Width (in)	N/A
	X Walk 1 Slope (%)	4.2		X Walk 2 Slope (%)	N/A
	X Walk 1 X Slope (%)	3.9		X Walk 2 X Slope (%)	N/A

N/A	Ramp inside XWalk1?	N/A	N/A	Ramp inside XWalk2?	N/A
	Road Slope (%)	N/A	N/A	Clear Space?	N/A
	Road X Slope (%)	N/A	N/A	Clear Space to XWalk (in)	N/A
N/A	Any Obstructions?	N/A	N/A	Storm Grate/Utility Hazard?	N/A
	Obstruction Type			Storm Grate/Utility Type	
		N/A			N/A
			Yes	Surface Condition? (G/P)	Good

Possible Solutions:

**Remove & Replace Entire Ramp.**

**R304.5.1, R304.2.2, R304.5.3**
