Access Compliance Report

Public Rights-of-Way

(Curb Ramps)

Intersection ID: 3033	Main Street: DEARMON_RD	Cross Street: BENFIELD_RD	Location:	S
ADA ID: C29DF39748E7	Ramp Type: Perp	Initial Pass/Fail: Fail	Overall Compliance: No	Severity Score: 25

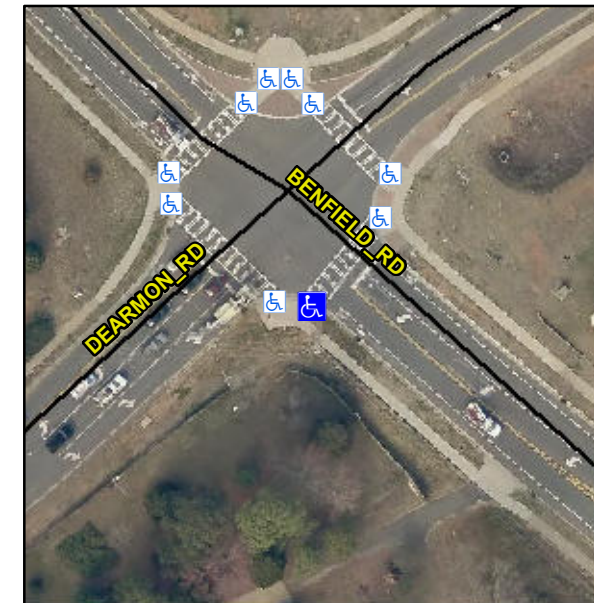
Compliance	Description	Data	Compliance	Description	Data
N/A	Ramp Length (in)	93.5	No	Ramp Slope (%)	12.9
Yes	Ramp Width (in)	84.0	Yes	Ramp XSlope (%)	1.8
N/A	Flare Type LT	N/A	N/A	Flare Type RT	N/A
N/A	Flare Slope LT (%)	N/A	N/A	Flare Slope RT (%)	N/A
N/A	Flare Traversable LT?	N/A	N/A	Flare Traversable RT?	N/A
N/A	Landing Length (in)	N/A	N/A	DWS Provided?	N/A
N/A	Landing Width (in)	N/A	N/A	DWS Contrast?	N/A
N/A	Landing Slope (%)	N/A	N/A	DWS Length (in)	N/A
N/A	Landing X Slope (%)	N/A	N/A	DWS Full Width?	N/A
N/A	Landing Curb? (Y/N)	N/A	N/A	DWS Offset (in)	N/A
N/A	Shared Landing?	N/A			
N/A	Gutter Ponding?	N/A	N/A	Gutter Slope (%)	N/A
N/A	Gutter Lip Ht (in)	N/A	N/A	Gutter X Slope (%)	N/A
N/A	Painted X Walk1?	Yes	N/A	Painted X Walk2?	N/A
	X Walk 1 Direction	To NE		X Walk 2 Direction	N/A
N/A	X Walk 1 Width (in)	111.0	N/A	X Walk 2 Width (in)	N/A
	X Walk 1 Slope (%)	0.2		X Walk 2 Slope (%)	N/A
	X Walk 1 X Slope (%)	1.7		X Walk 2 X Slope (%)	N/A

N/A	Ramp inside XWalk1?	Yes	N/A	Ramp inside XWalk2?	N/A
	Road Slope (%)	N/A	N/A	Clear Space?	N/A
	Road X Slope (%)	N/A	N/A	Clear Space to XWalk (in)	N/A
N/A	Any Obstructions?	N/A	N/A	Storm Grate/Utility Hazard?	N/A
	Obstruction Type			Storm Grate/Utility Type	
		N/A			N/A
			Yes	Surface Condition? (G/P)	Good

Remove & Replace Entire Ramp.

R304.2.2
