# Access Compliance Report

## Public Rights-of-Way

### (Curb Ramps)

Intersection ID: 4263	Main Street: DAVIS_LAKE_PY	Cross Street: SNOWS_ENTRY_PL	Location: N
ADA ID: C2A9A344786D	Ramp Type: Directional1	Initial Pass/Fail: Fail	Overall Compliance: No
			Severity Score: 46.25

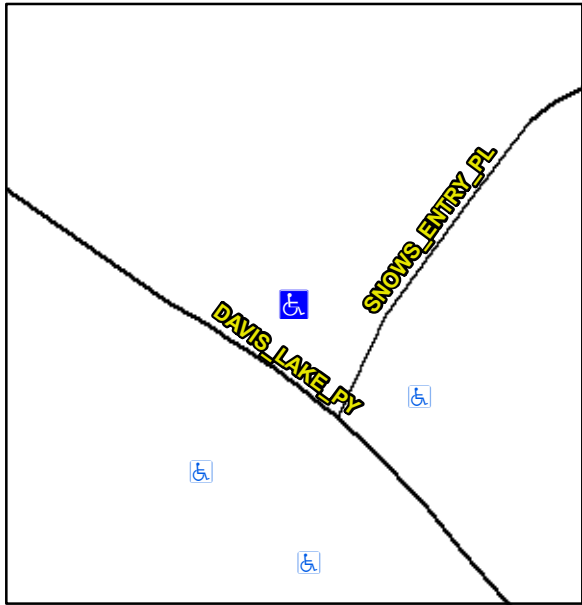
Possible Solutions:		Compliance			Description			Data	
	Remove & Replace Entire Ramp.		N/A	Ramp Length (in)	64.0	N/A	Grade Break?	N/A		
			No	Ramp Width (in)	43.0	N/A	Grade Break Slope (%)	0.0		
			No	Ramp Slope (%)	13.7	N/A	Grade Break XSlope (%)	0.0		
			No	Ramp XSlope (%)	6.1					
			N/A	Flare Type LT	N/A	N/A	Flare Type RT	N/A		
			N/A	Flare Slope LT (%)	N/A	N/A	Flare Slope RT (%)	0.0		
			N/A	Flare Traversable LT?	N/A	N/A	Flare Traversable RT?	N/A		
			N/A	Landing Length (in)	0.0	N/A	DWS Provided?	N/A		
			N/A	Landing Width (in)	0.0	N/A	DWS Contrast?	N/A		
Surveyor Notes:  N/A	PROW/ADA:		N/A	Landing Slope (%)	0.0	N/A	DWS Length (in)	N/A		
	R304.5.1, R304.2.2, R304.5.3		N/A	Landing X Slope (%)	0.0	N/A	DWS Full Width?	N/A		
			N/A	Landing Curb? (Y/N)	N/A	N/A	DWS Offset LT (in)	N/A		
			N/A	Shared Landing?	N/A	N/A	DWS Offset RT (in)	N/A

N/A	Gutter Ponding?	0.0	N/A	Gutter Slope (%)	N/A		
			N/A	Gutter Lip Ht (in)	0.0	N/A	Gutter X Slope (%)	N/A		
			N/A	Painted X Walk1?	No		Road Slope (%)	8.3		
				X Walk 1 Direction	To SE		Road X Slope (%)	0.3		
				X Walk 1 Width (in)	N/A		Clear Space?	N/A		
				X Walk 1 Slope (%)	8.3	N/A	Clear Space to XWalk (in)	N/A		
Street 1 Name SNOWS ENTRY PL Stop Condition-Street 1 StopSign Street 2 Name N/A Stop Condition-Street 2 N/A				X Walk 1 X Slope (%)	0.3	N/A	Storm Grate/Utility Hazard?	N/A		
			N/A	Ramp inside XWalk1?	N/A		Storm Grate/Utility Type			
			N/A	Any Obstructions?	N/A			N/A		
				Obstruction Type		Yes	Surface Condition? (G/P)	Good		
					N/A	N/A	Curb Slope (%)	N/A		
	Total Cost:		\$	1600.00
