Access Compliance Report

Public Rights-of-Way

(Curb Ramps)

Intersection ID: 7710	Main Street: MONTANA_DR	Cross Street: SENIOR_DR	Location: SE
ADA ID: C2AE48729D39	Ramp Type: Combination1	Initial Pass/Fail: Fail	Overall Compliance: No
		Severity Score: 67.5

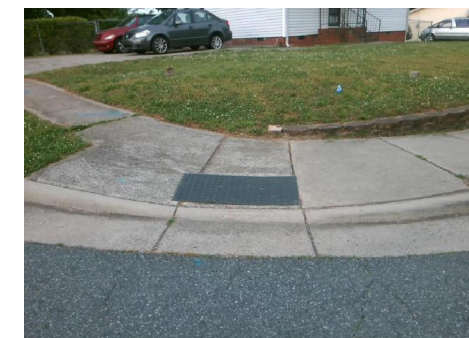
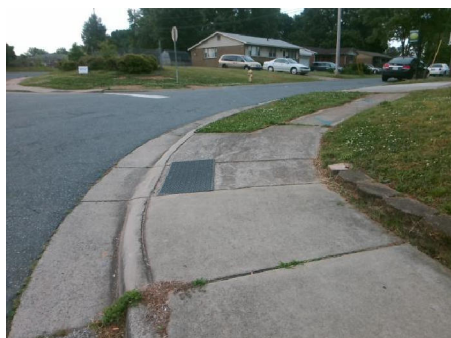
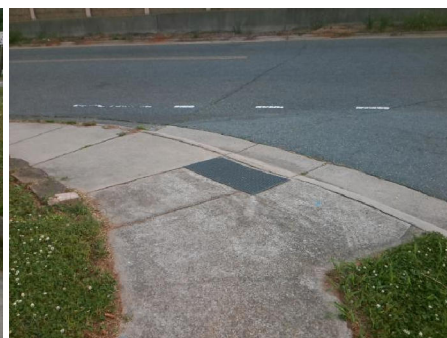
RT RP < 5%

R304.5.1, R304.5.3, R304.3.2

Compliance	Description	Data	Compliance	Description	Data
N/A	Ramp Length LT (in)	26.0	N/A	Ramp Length RT (in)	47.0
Yes	Ramp Width LT (in)	48.0	Yes	Ramp Width RT (in)	84.0
No	Ramp Slope LT (%)	12.7	Yes	Ramp Slope RT (%)	4.9
No	Ramp XSlope LT (%)	3.2	No	Ramp XSlope RT (%)	2.5
N/A	Ramp Length (in)	84.0	Yes	Ramp Slope (%)	6.8
No	Ramp Width (in)	35.0	No	Ramp XSlope (%)	10.0
N/A	Flare Type LT	N/A	N/A	Flare Type RT	N/A
N/A	Flare Slope LT (%)	N/A	N/A	Flare Slope RT (%)	N/A
N/A	Flare Traversable LT?	N/A	N/A	Flare Traversable RT?	N/A
N/A	Landing Length (in)	N/A	N/A	DWS Provided?	N/A
N/A	Landing Width (in)	N/A	N/A	DWS Contrast?	N/A
N/A	Landing Slope (%)	N/A	N/A	DWS Length (in)	N/A
N/A	Landing X Slope (%)	N/A	N/A	DWS Full Width?	N/A
N/A	Landing Curb? (Y/N)	N/A	N/A	DWS Offset (in)	N/A
N/A	Shared Landing?	N/A			
N/A	Gutter Ponding?	N/A	N/A	Gutter Slope (%)	N/A
N/A	Gutter Lip Ht (in)	N/A	N/A	Gutter X Slope (%)	N/A
N/A	Painted X Walk1?	No	N/A	Painted X Walk2?	N/A

Remove & Replace Entire Ramp.
