Access Compliance Report Public Rights-of-Way (Curb Ramps)

Intersection ID: 14337	Main Street: BERKELEY AV			Cross Street: E_MOREHEAD_ST					w
							Location:		
ADA ID: C2AE59836D67 Ramp Type: PerpDiag		Initial I	nitial Pass/Fail: Fail Overall Compliance: No				o Severity Score:	33.75	
Codes/Mitigation Info/Possible Solution				Field Measurements/Component Compliance					
		Possible Solutions:		Compliance Description		Data Compliance		liance Description	Data
A CARE		Remove & Replace Curb Ramp W	/ith	N/A	Ramp Length (in)	64.0	No	Ramp Slope (%)	13.2
		Two New Directional Ramps or		No	Ramp Width (in)	47.0	Yes	Ramp XSlope (%)	0.4
2	/ /	Equivalent.		N/A	Flare Type LT	N/A	N/A	Flare Type RT	N/A
ton ton				N/A	Flare Slope LT (%)	N/A	N/A	Flare Slope RT (%)	N/A

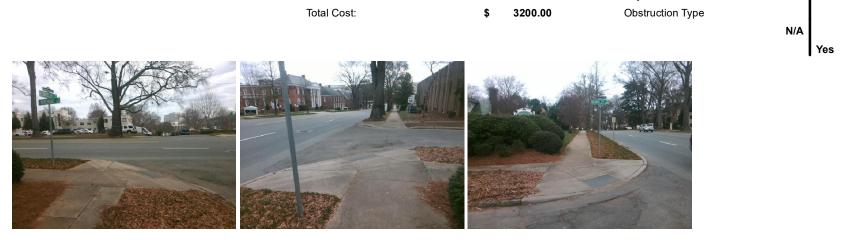
Stop Condition-Street 1	None				Road Slope (%)	1.4	N/A	Clear Space?	N/A
					Road X Slope (%)	5.0	N/A	Clear Space to XWalk (in)	N/A
				N/A	Any Obstructions?	N/A	N/A	Storm Grate/Utility Hazard?	N/A
		Total Cost: \$ 32	200.00		Obstruction Type			Storm Grate/Utility Type	
						N/A			N/A
