Access Compliance Report

Public Rights-of-Way

(Curb Ramps)

Intersection ID: 10027081	Main Street: GALLERIA_BV	Cross Street: N/A	Location:	N
ADA ID: C2B8A5029DC6	Ramp Type: Perp	Initial Pass/Fail: Fail	Overall Compliance: No	Severity Score: 10

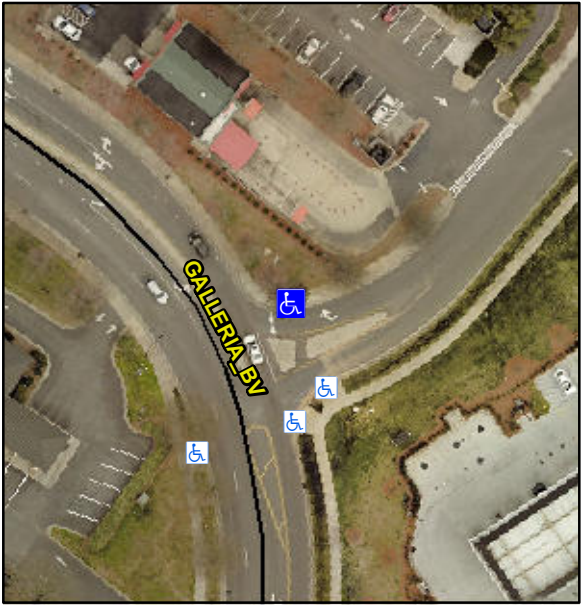
Possible Solutions:		Compliance	Description	Data	
	Remove & Replace Entire Ramp.		N/A	Ramp Length (in)	72.0	Yes
			No	Ramp Width (in)	39.0	No
			N/A	Flare Type LT	N/A	N/A
			N/A	Flare Slope LT (%)	N/A	N/A
			N/A	Flare Traversable LT?	N/A	N/A
			N/A	Landing Length (in)	N/A	N/A
			N/A	Landing Width (in)	N/A	N/A
			N/A	Landing Slope (%)	N/A	N/A
			N/A	Landing X Slope (%)	N/A	N/A
<p>Surveyor Notes:</p> <p>N/A</p> <p>PROW/ADA:</p> <p>R304.5.1, R304.5.3</p>			N/A	Flare Type RT	N/A	N/A
			N/A	Flare Slope RT (%)	N/A	N/A
			N/A	Flare Traversable RT?	N/A	N/A
			N/A	DWS Provided?	N/A	N/A
			N/A	DWS Contrast?	N/A	N/A
			N/A	DWS Length (in)	N/A	N/A
			N/A	DWS Full Width?	N/A	N/A
			N/A	DWS Offset (in)	N/A	N/A
			N/A	Gutter Ponding?	N/A	N/A
			N/A	Gutter Lip Ht (in)	N/A	N/A
<p>Street 1 Name</p> <p>Stop Condition-Street 2</p> <p>Street 2 Name</p> <p>Stop Condition-Street 1</p>			N/A	Painted X Walk1?	No	N/A

X Walk 1 Direction	To S	
			N/A	X Walk 1 Width (in)	N/A	N/A
				X Walk 1 Slope (%)	1.6	
				X Walk 1 X Slope (%)	1.8	
			N/A	Ramp inside XWalk1?	N/A	N/A
				Road Slope (%)	N/A	N/A
				Road X Slope (%)	N/A	N/A
			N/A	Any Obstructions?	N/A	N/A
				Obstruction Type		
Total Cost:		\$ 1850.00				
			N/A			N/A
			Yes	Surface Condition? (G/P)		Good
