Access Compliance Report

Public Rights-of-Way

(Curb Ramps)

| Intersection ID: 3809 | Main Street: MOUNTAIN_TRAIL_DR | Cross Street: MT_ISLE_HARBOR_DR | Location: NE |

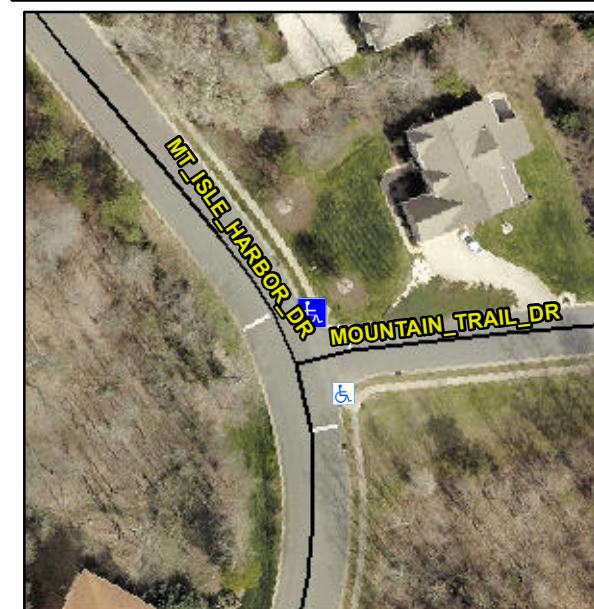
| ADA ID: C2BEE8794D94 | Ramp Type: Perp | Initial Pass/Fail: Fail | Overall Compliance: No |
| Severity Score: 10 | | | |

R304.5.1, R304.5.3

| Compliance | Description | Data | Compliance | Description | Data |
|---|---|---|---|---|---|
| N/A | Ramp Length (in) | 41.0 | Yes | Ramp Slope (%) | 5.0 |
| No | Ramp Width (in) | 47.5 | No | Ramp XSlope (%) | 2.1 |

Possible Solutions:

Remove & Replace Entire Ramp.

Total Cost: \$ 1850.00
