# Access Compliance Report

## Public Rights-of-Way

### (Curb Ramps)

Intersection ID: 14441	Main Street: E_KINGSTON_AV	Cross Street: SPRINGDALE_AV	Location: W
ADA ID: C2BF74A1F35D	Ramp Type: Perp	Initial Pass/Fail: Fail	Overall Compliance: No
Codes/Mitigation Info/Possible Solution			Severity Score: 25
			Field Measurements/Component Compliance

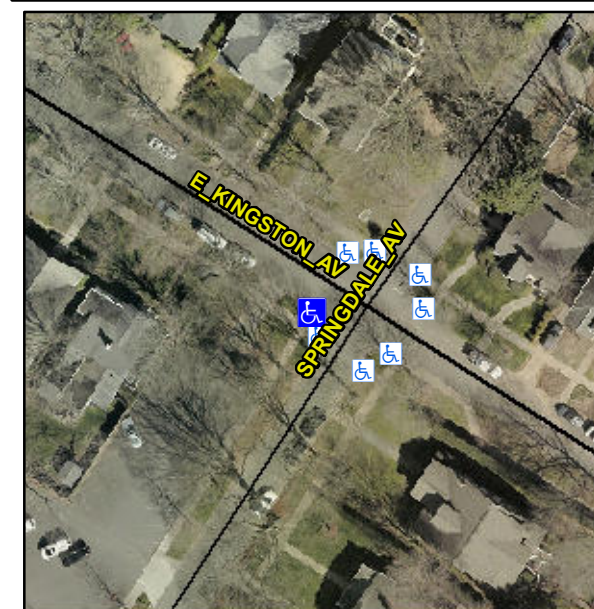
**Not Found, R304.2.2, R304.5.3**

Compliance	Description	Data	Compliance	Description	Data
N/A	Ramp Length (in)	80.0	No	Ramp Slope (%)	8.6
Yes	Ramp Width (in)	49.0	No	Ramp XSlope (%)	6.5
N/A	Flare Type LT	N/A	N/A	Flare Type RT	N/A
N/A	Flare Slope LT (%)	N/A	N/A	Flare Slope RT (%)	N/A
N/A	Flare Traversable LT?	N/A	N/A	Flare Traversable RT?	N/A
N/A	Landing Length (in)	N/A	N/A	DWS Provided?	N/A
N/A	Landing Width (in)	N/A	N/A	DWS Contrast?	N/A
N/A	Landing Slope (%)	N/A	N/A	DWS Length (in)	N/A
N/A	Landing X Slope (%)	N/A	N/A	DWS Full Width?	N/A
N/A	Landing Curb? (Y/N)	N/A	N/A	DWS Offset (in)	N/A
N/A	Shared Landing?	N/A			
N/A	Gutter Ponding?	N/A	N/A	Gutter Slope (%)	N/A
N/A	Gutter Lip Ht (in)	N/A	N/A	Gutter X Slope (%)	N/A
N/A	Painted X Walk1?	No	N/A	Painted X Walk2?	N/A
	X Walk 1 Direction	To NE		X Walk 2 Direction	N/A
N/A	X Walk 1 Width (in)	N/A	N/A	X Walk 2 Width (in)	N/A
	X Walk 1 Slope (%)	9.0		X Walk 2 Slope (%)	N/A
	X Walk 1 X Slope (%)	1.3		X Walk 2 X Slope (%)	N/A

N/A	Ramp inside XWalk1?	N/A	N/A	Ramp inside XWalk2?	N/A
	Road Slope (%)	N/A	N/A	Clear Space?	N/A
	Road X Slope (%)	N/A	N/A	Clear Space to XWalk (in)	N/A
N/A	Any Obstructions?	N/A	N/A	Storm Grate/Utility Hazard?	N/A
	Obstruction Type			Storm Grate/Utility Type	
		N/A			N/A
			Yes	Surface Condition? (G/P)	Good

**Remove & Replace Entire Ramp.**

Total Cost: \$ 1850.00
