# Access Compliance Report

## Public Rights-of-Way

### (Curb Ramps)

| Intersection ID: N/A | Main Street: HORACE_ST | Cross Street: N/A | Location: SW |

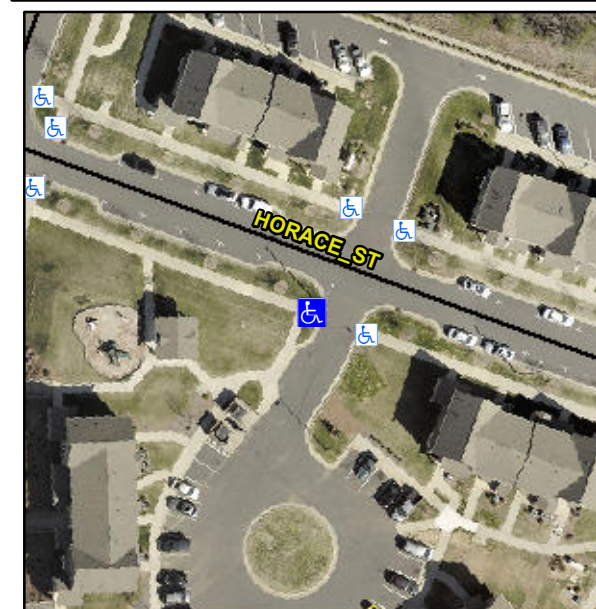
| ADA ID: C2C5B0BFB305 | Ramp Type: Perp | Initial Pass/Fail: Fail | Overall Compliance: No |
| Severity Score: 1.25 | | | |

| Compliance | Description | Data | Compliance | Description | Data |
|---|---|---|---|---|---|
| N/A | Ramp Length (in) | 73.0 | Yes | Ramp Slope (%) | 4.1 |
| Yes | Ramp Width (in) | 72.0 | No | Ramp XSlope (%) | 2.3 |

**Remove & Replace Entire Ramp.**

**R304.5.3**

**\$ 1850.00**
