# Access Compliance Report

## Public Rights-of-Way

### (Curb Ramps)

Intersection ID: 9248	Main Street: KALYNNE_ST	Cross Street: RAMONA_ST	Location:	N
ADA ID: C2D79F480032	Ramp Type: Perp	Initial Pass/Fail: Fail	Overall Compliance: No	Severity Score: 21.25
Codes/Mitigation Info/Possible Solution		Field Measurements/Component Compliance

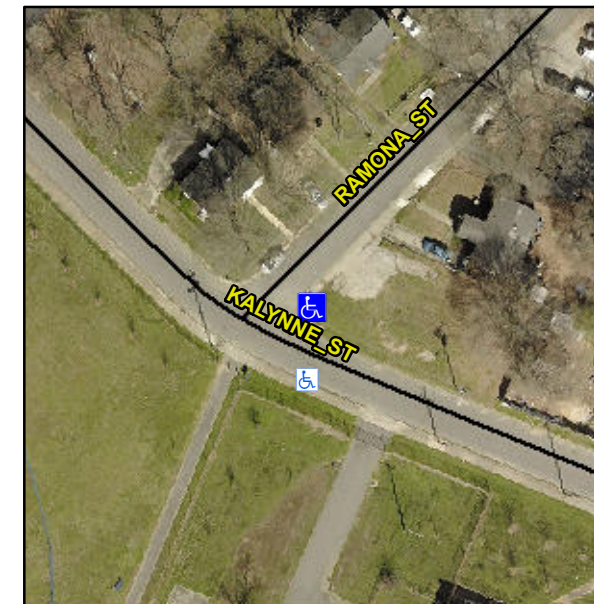
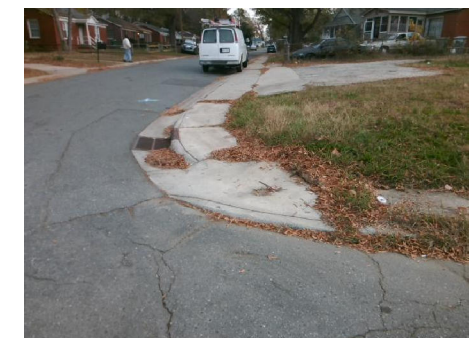
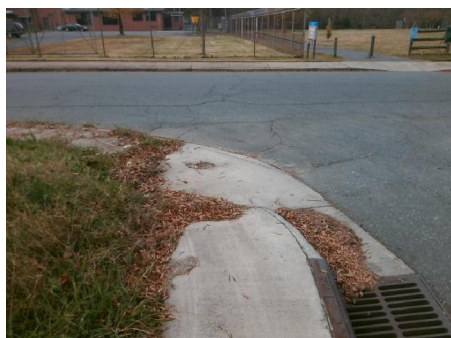
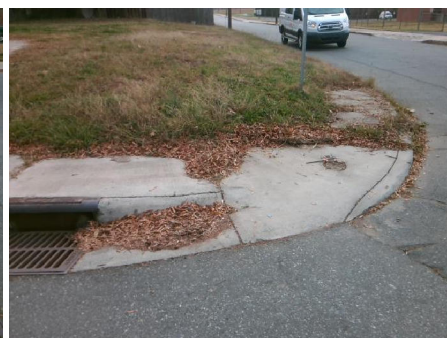
**Not Found, R304.5.1, R304.2.2**

Compliance	Description	Data	Compliance	Description	Data
N/A	Ramp Length (in)	60.0	No	Ramp Slope (%)	11.2
No	Ramp Width (in)	44.0	Yes	Ramp XSlope (%)	1.0
N/A	Flare Type LT	N/A	N/A	Flare Type RT	N/A
N/A	Flare Slope LT (%)	N/A	N/A	Flare Slope RT (%)	N/A
N/A	Flare Traversable LT?	N/A	N/A	Flare Traversable RT?	N/A
N/A	Landing Length (in)	N/A	N/A	DWS Provided?	N/A
N/A	Landing Width (in)	N/A	N/A	DWS Contrast?	N/A
N/A	Landing Slope (%)	N/A	N/A	DWS Length (in)	N/A
N/A	Landing X Slope (%)	N/A	N/A	DWS Full Width?	N/A
N/A	Landing Curb? (Y/N)	N/A	N/A	DWS Offset (in)	N/A
N/A	Shared Landing?	N/A			
N/A	Gutter Ponding?	N/A	N/A	Gutter Slope (%)	N/A
N/A	Gutter Lip Ht (in)	N/A	N/A	Gutter X Slope (%)	N/A
N/A	Painted X Walk1?	No	N/A	Painted X Walk2?	N/A
	X Walk 1 Direction	To S		X Walk 2 Direction	N/A
N/A	X Walk 1 Width (in)	N/A	N/A	X Walk 2 Width (in)	N/A
	X Walk 1 Slope (%)	1.3		X Walk 2 Slope (%)	N/A
	X Walk 1 X Slope (%)	0.5		X Walk 2 X Slope (%)	N/A

N/A	Ramp inside XWalk1?	N/A	N/A	Ramp inside XWalk2?	N/A
	Road Slope (%)	N/A	N/A	Clear Space?	N/A
	Road X Slope (%)	N/A	N/A	Clear Space to XWalk (in)	N/A
N/A	Any Obstructions?	N/A	N/A	Storm Grate/Utility Hazard?	N/A
	Obstruction Type			Storm Grate/Utility Type	
		N/A			N/A
			Yes	Surface Condition? (G/P)	Good

**Remove & Replace Entire Ramp.**
