Access Compliance Report

Public Rights-of-Way

(Curb Ramps)

Intersection ID: 26209	Main Street: CARMEL_RD	Cross Street: JOHNSTON_RD	Location: S
ADA ID: C2D9DB965A27	Ramp Type: Perp	Initial Pass/Fail: Fail	Overall Compliance: No
Severity Score: 21.25			
Codes/Mitigation Info/Possible Solution		Field Measurements/Component Compliance

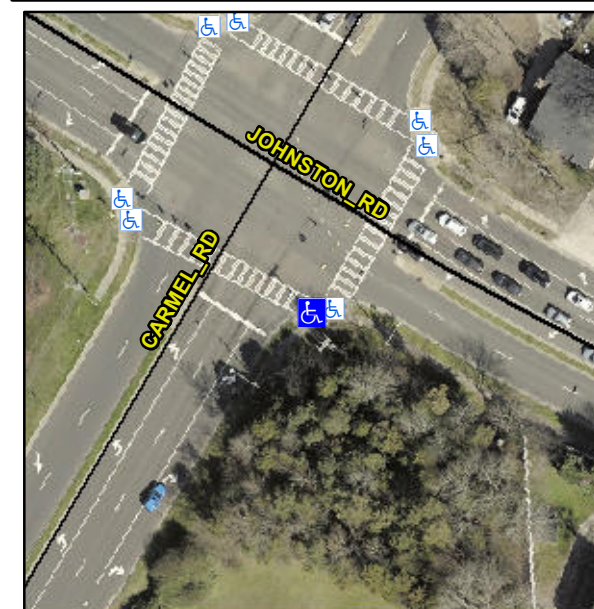
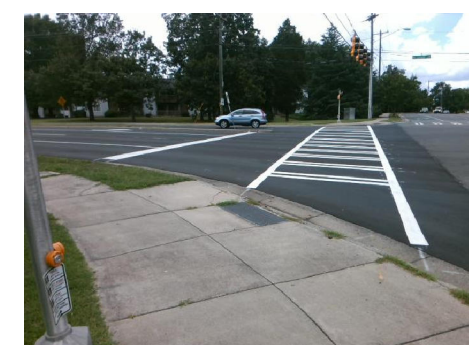
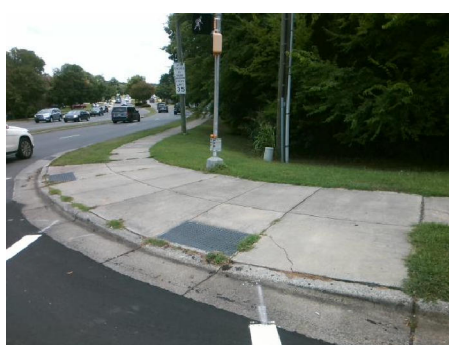
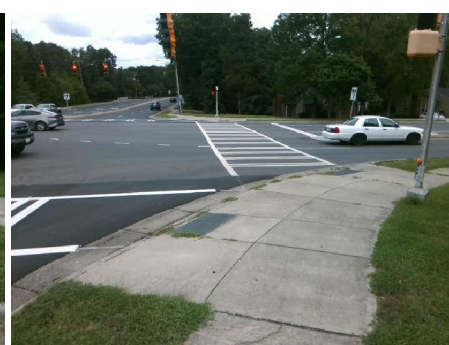
Not Found, R304.5.1, R304.5.3

Compliance	Description	Data	Compliance	Description	Data
N/A	Ramp Length (in)	60.0	Yes	Ramp Slope (%)	7.5
No	Ramp Width (in)	46.5	No	Ramp XSlope (%)	6.0
N/A	Flare Type LT	N/A	N/A	Flare Type RT	N/A
N/A	Flare Slope LT (%)	N/A	N/A	Flare Slope RT (%)	N/A
N/A	Flare Traversable LT?	N/A	N/A	Flare Traversable RT?	N/A
N/A	Landing Length (in)	N/A	N/A	DWS Provided?	N/A
N/A	Landing Width (in)	N/A	N/A	DWS Contrast?	N/A
N/A	Landing Slope (%)	N/A	N/A	DWS Length (in)	N/A
N/A	Landing X Slope (%)	N/A	N/A	DWS Full Width?	N/A
N/A	Landing Curb? (Y/N)	N/A	N/A	DWS Offset (in)	N/A
N/A	Shared Landing?	N/A			
N/A	Gutter Ponding?	N/A	N/A	Gutter Slope (%)	N/A
N/A	Gutter Lip Ht (in)	N/A	N/A	Gutter X Slope (%)	N/A
N/A	Painted X Walk1?	Yes	N/A	Painted X Walk2?	N/A
	X Walk 1 Direction	To NW		X Walk 2 Direction	N/A
N/A	X Walk 1 Width (in)	112.0	N/A	X Walk 2 Width (in)	N/A
	X Walk 1 Slope (%)	3.5		X Walk 2 Slope (%)	N/A
	X Walk 1 X Slope (%)	4.1		X Walk 2 X Slope (%)	N/A

N/A	Ramp inside XWalk1?	Yes	N/A	Ramp inside XWalk2?	N/A
	Road Slope (%)	N/A	N/A	Clear Space?	N/A
	Road X Slope (%)	N/A	N/A	Clear Space to XWalk (in)	N/A
N/A	Any Obstructions?	N/A	N/A	Storm Grate/Utility Hazard?	N/A
	Obstruction Type			Storm Grate/Utility Type	
		N/A			N/A
		Yes		Surface Condition? (G/P)	Good

Possible Solutions:

Remove & Replace Entire Ramp.

Total Cost: \$ 1850.00
