Access Compliance Report

Public Rights-of-Way

(Curb Ramps)

Intersection ID: N/A	Main Street: WINDSOR_GATE_LN	Cross Street: W_T_HARRIS_BV	Location: SE
ADA ID: C2D9E9EF7D04	Ramp Type: PerpDiag	Initial Pass/Fail: Fail	Overall Compliance: No
Severity Score: 37.5			
Codes/Mitigation Info/Possible Solution		Field Measurements/Component Compliance

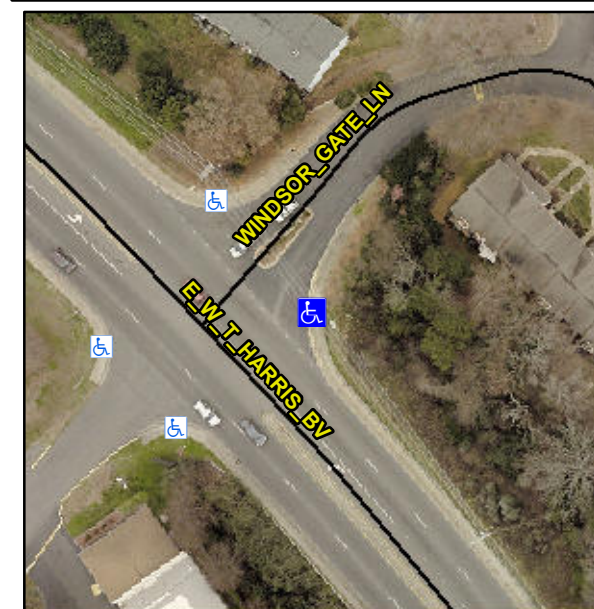
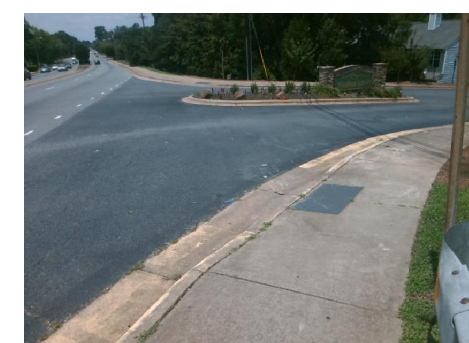
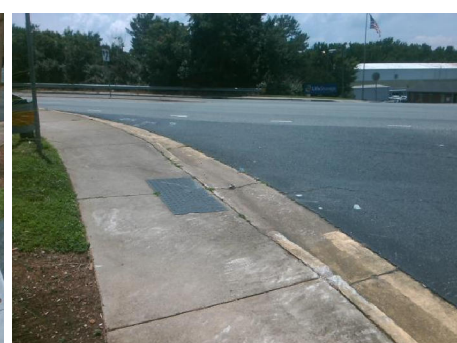
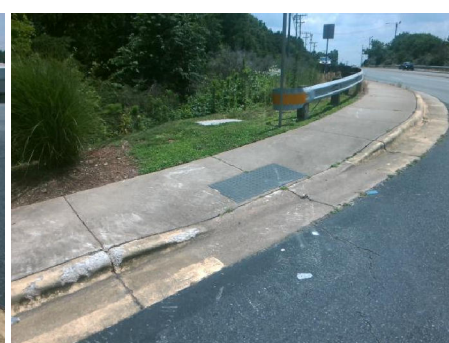
Not Found, R304.2.2, R304.5.3

Compliance	Description	Data	Compliance	Description	Data
N/A	Ramp Length (in)	60.0	No	Ramp Slope (%)	11.0
Yes	Ramp Width (in)	89.0	No	Ramp XSlope (%)	9.2
N/A	Flare Type LT	N/A	N/A	Flare Type RT	N/A
N/A	Flare Slope LT (%)	N/A	N/A	Flare Slope RT (%)	N/A
N/A	Flare Traversable LT?	N/A	N/A	Flare Traversable RT?	N/A
N/A	Landing Length (in)	N/A	N/A	DWS Provided?	N/A
N/A	Landing Width (in)	N/A	N/A	DWS Contrast?	N/A
N/A	Landing Slope (%)	N/A	N/A	DWS Length (in)	N/A
N/A	Landing X Slope (%)	N/A	N/A	DWS Full Width?	N/A
N/A	Landing Curb? (Y/N)	N/A	N/A	DWS Offset (in)	N/A
N/A	Shared Landing?	N/A			
N/A	Gutter Ponding?	N/A	N/A	Gutter Slope (%)	N/A
N/A	Gutter Lip Ht (in)	N/A	N/A	Gutter X Slope (%)	N/A
N/A	Painted X Walk1?	No	N/A	Painted X Walk2?	No
	X Walk 1 Direction	To NW		X Walk 2 Direction	To SW
N/A	X Walk 1 Width (in)	N/A	N/A	X Walk 2 Width (in)	N/A
	X Walk 1 Slope (%)	0.4		X Walk 2 Slope (%)	6.3
	X Walk 1 X Slope (%)	6.7		X Walk 2 X Slope (%)	1.9

N/A	Ramp inside XWalk1?	N/A	N/A	Ramp inside XWalk2?	N/A
	Road Slope (%)	6.9	N/A	Clear Space?	N/A
	Road X Slope (%)	3.9	N/A	Clear Space to XWalk (in)	N/A
N/A	Any Obstructions?	N/A	N/A	Storm Grate/Utility Hazard?	N/A
	Obstruction Type			Storm Grate/Utility Type	
		N/A			N/A
		Yes		Surface Condition? (G/P)	Good

Remove & Replace Curb Ramp With Two New Directional Ramps or Equivalent.
