## **Access Compliance Report Public Rights-of-Way** (Curb Ramps)

Intersection ID: 30566 Main Street: HAMILTON GREEN DR **Cross Street: CIRCLEGREEN DR** Location: NE ADA ID: C2DF15DAFF06 Ramp Type: PerpDiag Initial Pass/Fail: Fail **Overall Compliance: No Severity Score:** 37.5

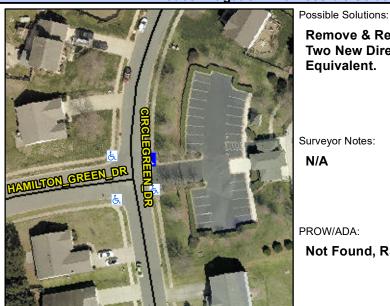
o New Directional Ramps or uivalent.
eyor Notes:
A
W/ADA:
t Found, R304.2.2, R304.5.3

Compliance Description		Data	Comp	oliance Description	Data
N/A	Ramp Length (in)	95.0	No	Ramp Slope (%)	14.0
Yes	Ramp Width (in)	48.0	No	Ramp XSlope (%)	5.1
N/A	Flare Type LT	N/A	N/A	Flare Type RT	N/A
N/A	Flare Slope LT (%)	N/A	N/A	Flare Slope RT (%)	N/A
N/A	Flare Traversable LT?	N/A	N/A	Flare Traversable RT?	N/A
N/A	Landing Length (in)	N/A	N/A	DWS Provided?	N/A
N/A	Landing Width (in)	N/A	N/A	DWS Contrast?	N/A
N/A	Landing Slope (%)	N/A	N/A	DWS Length (in)	N/A
N/A	Landing X Slope (%)	N/A	N/A	DWS Full Width?	N/A
N/A	Landing Curb? (Y/N)	N/A	N/A	DWS Offset (in)	N/A
N/A	Shared Landing?	N/A			
N/A	Gutter Ponding?	N/A	N/A	Gutter Slope (%)	N/A
N/A	Gutter Lip Ht (in)	N/A	N/A	Gutter X Slope (%)	N/A
N/A	Painted X Walk1?	No	N/A	Painted X Walk2?	No
	X Walk 1 Direction	To W		X Walk 2 Direction	To S
N/A	X Walk 1 Width (in)	N/A	N/A	X Walk 2 Width (in)	N/A
	X Walk 1 Slope (%)	3.3		X Walk 2 Slope (%)	0.5
	X Walk 1 X Slope (%)	0.7		X Walk 2 X Slope (%)	1.7

N/A	Ramp inside XWalk1?	N/A	N/A	Ramp inside XWalk2?	N/A
	Road Slope (%)	0.7	N/A	Clear Space?	N/A
	Road X Slope (%)	0.8	N/A	Clear Space to XWalk (in)	N/A
N/A	Any Obstructions?	N/A	N/A	Storm Grate/Utility Hazard?	N/A
	Obstruction Type			Storm Grate/Utility Type	
		N/A			N/A
			Yes	Surface Condition? (G/P)	Good

Remove & Replace Curb Ramp With Equ

Total Cost: 3200.00
