Access Compliance Report

Public Rights-of-Way

(Curb Ramps)

Intersection ID: 14530	Main Street: E_5TH_ST	Cross Street: N_LAUREL_AV	Location: W
ADA ID: C2E4CEE98574	Ramp Type: Perp	Initial Pass/Fail: Fail	Overall Compliance: No
			Severity Score: 21.25

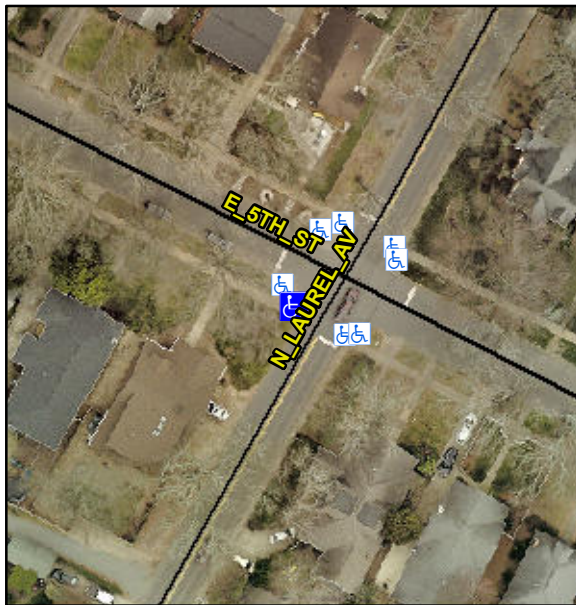
Compliance	Description	Data	Compliance	Description	Data
N/A	Ramp Length (in)	54.0	No	Ramp Slope (%)	10.5
No	Ramp Width (in)	41.0	Yes	Ramp XSlope (%)	2.0
N/A	Flare Type LT	N/A	N/A	Flare Type RT	N/A
N/A	Flare Slope LT (%)	N/A	N/A	Flare Slope RT (%)	N/A
N/A	Flare Traversable LT?	N/A	N/A	Flare Traversable RT?	N/A
N/A	Landing Length (in)	N/A	N/A	DWS Provided?	N/A
N/A	Landing Width (in)	N/A	N/A	DWS Contrast?	N/A
N/A	Landing Slope (%)	N/A	N/A	DWS Length (in)	N/A
N/A	Landing X Slope (%)	N/A	N/A	DWS Full Width?	N/A
N/A	Landing Curb? (Y/N)	N/A	N/A	DWS Offset (in)	N/A
N/A	Shared Landing?	N/A			
N/A	Gutter Ponding?	N/A	N/A	Gutter Slope (%)	N/A
N/A	Gutter Lip Ht (in)	N/A	N/A	Gutter X Slope (%)	N/A
N/A	Painted X Walk1?	No	N/A	Painted X Walk2?	N/A
	X Walk 1 Direction	To SE		X Walk 2 Direction	N/A
N/A	X Walk 1 Width (in)	N/A	N/A	X Walk 2 Width (in)	N/A
	X Walk 1 Slope (%)	0.4		X Walk 2 Slope (%)	N/A
	X Walk 1 X Slope (%)	3.7		X Walk 2 X Slope (%)	N/A

N/A	Ramp inside XWalk1?	N/A	N/A	Ramp inside XWalk2?	N/A
	Road Slope (%)	N/A	N/A	Clear Space?	N/A
	Road X Slope (%)	N/A	N/A	Clear Space to XWalk (in)	N/A
N/A	Any Obstructions?	N/A	N/A	Storm Grate/Utility Hazard?	N/A
	Obstruction Type			Storm Grate/Utility Type	
		N/A			N/A
			Yes	Surface Condition? (G/P)	Good

Remove & Replace Entire Ramp.
