Access Compliance Report

Public Rights-of-Way

(Curb Ramps)

Intersection ID: 25211	Main Street: SMITH_RD	Cross Street: SOUTHBRIDGE_FOREST_DR	Location: SE
ADA ID: C2F05F0EB45F	Ramp Type: Perp	Initial Pass/Fail: Fail	Overall Compliance: No
		Severity Score: 12.5

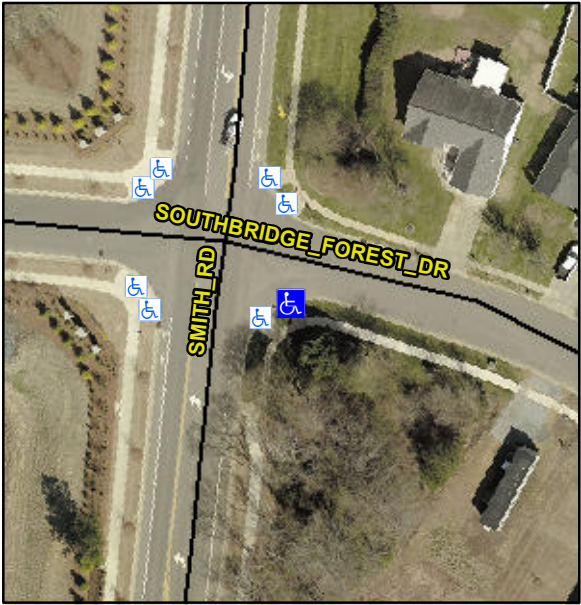
Compliance	Description	Data	Compliance	Description	Data
N/A	Ramp Length (in)	116.0	No	Ramp Slope (%)	8.6
Yes	Ramp Width (in)	92.0	Yes	Ramp XSlope (%)	0.4
N/A	Flare Type LT	N/A	N/A	Flare Type RT	N/A
N/A	Flare Slope LT (%)	N/A	N/A	Flare Slope RT (%)	N/A
N/A	Flare Traversable LT?	N/A	N/A	Flare Traversable RT?	N/A
N/A	Landing Length (in)	N/A	N/A	DWS Provided?	N/A
N/A	Landing Width (in)	N/A	N/A	DWS Contrast?	N/A
N/A	Landing Slope (%)	N/A	N/A	DWS Length (in)	N/A
N/A	Landing X Slope (%)	N/A	N/A	DWS Full Width?	N/A
N/A	Landing Curb? (Y/N)	N/A	N/A	DWS Offset (in)	N/A
N/A	Shared Landing?	N/A			
N/A	Gutter Ponding?	N/A	N/A	Gutter Slope (%)	N/A
N/A	Gutter Lip Ht (in)	N/A	N/A	Gutter X Slope (%)	N/A
N/A	Painted X Walk1?	No	N/A	Painted X Walk2?	N/A
	X Walk 1 Direction	To NE		X Walk 2 Direction	N/A
N/A	X Walk 1 Width (in)	N/A	N/A	X Walk 2 Width (in)	N/A
	X Walk 1 Slope (%)	0.5		X Walk 2 Slope (%)	N/A
	X Walk 1 X Slope (%)	1.1		X Walk 2 X Slope (%)	N/A

N/A	Ramp inside XWalk1?	N/A	N/A	Ramp inside XWalk2?	N/A
	Road Slope (%)	N/A	N/A	Clear Space?	N/A
	Road X Slope (%)	N/A	N/A	Clear Space to XWalk (in)	N/A
N/A	Any Obstructions?	N/A	N/A	Storm Grate/Utility Hazard?	N/A
	Obstruction Type			Storm Grate/Utility Type	
		N/A			N/A
			Yes	Surface Condition? (G/P)	Good

Possible Solutions:				
	Remove & Replace Entire Ramp.				
	Surveyor Notes:				
	N/A				
	PROW/ADA:				
	R304.2.2				
Street 1 Name	SOUTHBRIDGE FOREST DR				
Stop Condition-Street 2	StopSign				
Street 2 Name	N/A				
Stop Condition-Street 1	N/A				
Total Cost:		\$	1850.00
