# Access Compliance Report

## Public Rights-of-Way

### (Curb Ramps)

Intersection ID: 10427	Main Street: CALLAHAN_ST	Cross Street: POLK_ST	Location: W
ADA ID: C2F62EEE01BC	Ramp Type: Perp	Initial Pass/Fail: Fail	Overall Compliance: No
Codes/Mitigation Info/Possible Solution		Field Measurements/Component Compliance	
Severity Score: 28.75

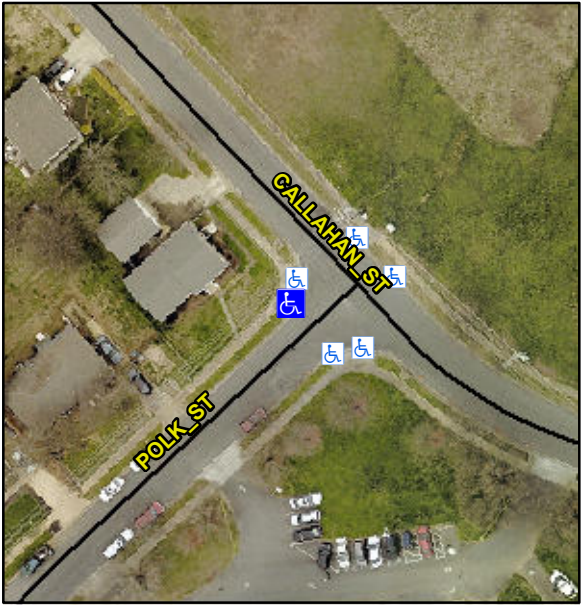
Possible Solutions:						
	Remove & Replace Entire Ramp.	N/A	Ramp Length (in)	56.0	No	Ramp Slope (%)	10.2
		Yes	Ramp Width (in)	48.0	No	Ramp XSlope (%)	3.9
		N/A	Flare Type LT	N/A	N/A	Flare Type RT	N/A
		N/A	Flare Slope LT (%)	N/A	N/A	Flare Slope RT (%)	N/A
		N/A	Flare Traversable LT?	N/A	N/A	Flare Traversable RT?	N/A
		N/A	Landing Length (in)	N/A	N/A	DWS Provided?	N/A
		N/A	Landing Width (in)	N/A	N/A	DWS Contrast?	N/A
		N/A	Landing Slope (%)	N/A	N/A	DWS Length (in)	N/A
		N/A	Landing X Slope (%)	N/A	N/A	DWS Full Width?	N/A
<p>Surveyor Notes:</p> <p>N/A</p> <p>PROW/ADA:</p> <p>Not Found, R304.2.2, R304.5.3, R302.7</p>		N/A	Landing Curb? (Y/N)	N/A	N/A	DWS Offset (in)	N/A
		N/A	Shared Landing?	N/A			
		N/A	Gutter Ponding?	N/A	N/A	Gutter Slope (%)	N/A
		N/A	Gutter Lip Ht (in)	1.0	N/A	Gutter X Slope (%)	N/A
		N/A	Painted X Walk1?	No	N/A	Painted X Walk2?	N/A
			X Walk 1 Direction	To SE		X Walk 2 Direction	N/A

N/A	X Walk 1 Width (in)	N/A	N/A	X Walk 2 Width (in)	N/A
			X Walk 1 Slope (%)	1.0		X Walk 2 Slope (%)	N/A
			X Walk 1 X Slope (%)	2.0		X Walk 2 X Slope (%)	N/A
		N/A	Ramp inside XWalk1?	N/A	N/A	Ramp inside XWalk2?	N/A
<p>Street 1 Name</p> <p>Stop Condition-Street 2</p> <p>Street 2 Name</p> <p>Stop Condition-Street 1</p>			Road Slope (%)	N/A	N/A	Clear Space?	N/A
			Road X Slope (%)	N/A	N/A	Clear Space to XWalk (in)	N/A
		N/A	Any Obstructions?	N/A	N/A	Storm Grate/Utility Hazard?	N/A
			Obstruction Type			Storm Grate/Utility Type	
				N/A			N/A
				No		Surface Condition? (G/P)	Poor
Total Cost:		\$	1850.00
