Access Compliance Report

Public Rights-of-Way

(Curb Ramps)

Intersection ID: N/A	Main Street: INVERNESS_BAY_RD	Cross Street: PERTH_MOOR_RD	Location: NW
ADA ID: C2F96BF1DAAC	Ramp Type: Perp	Initial Pass/Fail: Fail	Overall Compliance: No
		Severity Score: 10

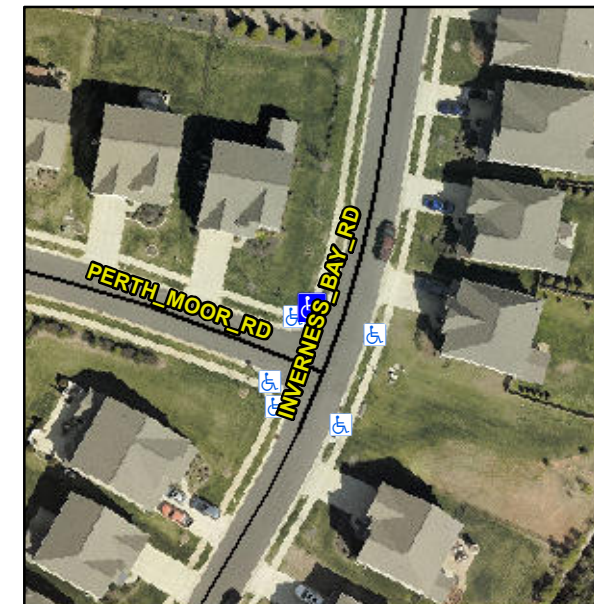
R304.5.1, R304.5.3

Compliance	Description	Data	Compliance	Description	Data
N/A	Ramp Length (in)	47.5	Yes	Ramp Slope (%)	7.1
No	Ramp Width (in)	42.0	No	Ramp XSlope (%)	4.3
N/A	Flare Type LT	N/A	N/A	Flare Type RT	N/A
N/A	Flare Slope LT (%)	N/A	N/A	Flare Slope RT (%)	N/A
N/A	Flare Traversable LT?	N/A	N/A	Flare Traversable RT?	N/A
N/A	Landing Length (in)	N/A	N/A	DWS Provided?	N/A
N/A	Landing Width (in)	N/A	N/A	DWS Contrast?	N/A
N/A	Landing Slope (%)	N/A	N/A	DWS Length (in)	N/A
N/A	Landing X Slope (%)	N/A	N/A	DWS Full Width?	N/A
N/A	Landing Curb? (Y/N)	N/A	N/A	DWS Offset (in)	N/A
N/A	Shared Landing?	N/A			
N/A	Gutter Ponding?	N/A	N/A	Gutter Slope (%)	N/A
N/A	Gutter Lip Ht (in)	N/A	N/A	Gutter X Slope (%)	N/A
N/A	Painted X Walk1?	No	N/A	Painted X Walk2?	N/A
	X Walk 1 Direction	To SE		X Walk 2 Direction	N/A
N/A	X Walk 1 Width (in)	N/A	N/A	X Walk 2 Width (in)	N/A
	X Walk 1 Slope (%)	0.8		X Walk 2 Slope (%)	N/A
	X Walk 1 X Slope (%)	3.4		X Walk 2 X Slope (%)	N/A

Remove & Replace Entire Ramp.
