Access Compliance Report Public Rights-of-Way (Curb Ramps)

Intersection ID: 9045 Main Street: JENNINGS_ST Cross Street: VINTON_ST Location: NE

ADA ID: C2FCF1B6135A Ramp Type: Perp Initial Pass/Fail: Fail Overall Compliance: No Severity Score: 21.25

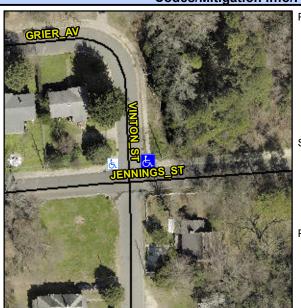
Field Measurements/Component Compliance						
Comp	liance Description	Data	Comp	liance	Description	Data
N/A	Ramp Length (in)	74.0	Yes	Ramp	Slope (%)	6.2
No	Ramp Width (in)	46.0	No	Ramp	XSlope (%)	6.8
N/A	Flare Type LT	N/A	N/A	Flare T	ype RT	N/A
N/A	Flare Slope LT (%)	N/A	N/A	Flare S	Slope RT (%)	N/A
N/A	Flare Traversable LT?	N/A	N/A	Flare T	raversable RT?	N/A
N/A	Landing Length (in)	N/A	N/A	DWS F	Provided?	N/A
N/A	Landing Width (in)	N/A	N/A	DWS (Contrast?	N/A
N/A	Landing Slope (%)	N/A	N/A	DWS L	ength (in)	N/A
N/A	Landing X Slope (%)	N/A	N/A	DWS F	Full Width?	N/A
N/A	Landing Curb? (Y/N)	N/A	N/A	DWS (Offset (in)	N/A
N/A	Shared Landing?	N/A				
N/A	Gutter Ponding?	N/A	N/A	Gutter	Slope (%)	N/A
N/A	Gutter Lip Ht (in)	N/A	N/A	Gutter	X Slope (%)	N/A
N/A	Painted X Walk1?	No	N/A	Painte	d X Walk2?	N/A
	X Walk 1 Direction	To W		X Walk	2 Direction	N/A
N/A	X Walk 1 Width (in)	N/A	N/A	X Walk	2 Width (in)	N/A
	X Walk 1 Slope (%)	8.2		X Walk	(2 Slope (%)	N/A

X Walk 1 X Slope (%)	0.1		X Walk	(2 X Slope (%)	N/A
N/A	Ramp inside XWalk1?	N/A	N/A	Ramp	inside XWalk2?	N/A
	Road Slope (%)	N/A	N/A	Clear S	Space?	N/A
	Road X Slope (%)	N/A	N/A	Clear S	Space to XWalk (in)	N/A
N/A	Any Obstructions?	N/A	N/A	Storm	Grate/Utility Hazard?	N/A
	Obstruction Type			Storm	Grate/Utility Type	
		N/A				N/A
			Yes	Surfac	e Condition? (G/P)	Good
The second second

<u> </u>	1 CCCIDIC CCIGNON	
	Possible Solutions:	<u>c</u>
9	Remove & Replace Entire Ramp.	N.
100		N
-		N
		N.
8		N.
1		N.
S.	Surveyor Notes:	N
k	N/A	N
É		N
		N
		N
1	PROW/ADA:	N
	Not Found, R304.5.1, R304.5.3	N
	,	N
		N
		N

1850.00
