Access Compliance Report Public Rights-of-Way (Curb Ramps)

Intersection ID: 49140Main Street:POPE_FARM_RDCross Street:CEMKEY_WAY_CTLocation:NEADA ID: C30354996F0CRamp Type:PerpInitial Pass/Fail:FailOverall Compliance:NoSeverity Score:8.75

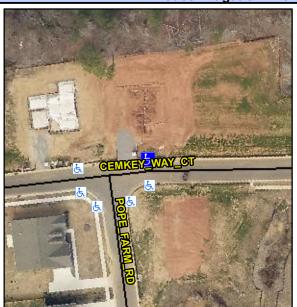
Field Measurements/Component Compliance								
Comp	liance Description	Data	Comp	liance	Description	Data		
N/A	Ramp Length (in)	46.0	Yes	Ramp	Slope (%)	6.4		
No	Ramp Width (in)	47.0	Yes	Ramp	XSlope (%)	0.6		
N/A	Flare Type LT	N/A	N/A	Flare	Гуре RT	N/A		
N/A	Flare Slope LT (%)	N/A	N/A	Flare	Slope RT (%)	N/A		
N/A	Flare Traversable LT?	N/A	N/A	Flare	Traversable RT?	N/A		
N/A	Landing Length (in)	N/A	N/A	DWS I	Provided?	N/A		
N/A	Landing Width (in)	N/A	N/A	DWS (Contrast?	N/A		
N/A	Landing Slope (%)	N/A	N/A	DWS I	_ength (in)	N/A		
N/A	Landing X Slope (%)	N/A	N/A	DWS I	Full Width?	N/A		
N/A	Landing Curb? (Y/N)	N/A	N/A	DWS (Offset (in)	N/A		
N/A	Shared Landing?	N/A						
N/A	Gutter Ponding?	N/A	N/A	Gutter	Slope (%)	N/A		
N/A	Gutter Lip Ht (in)	N/A	N/A	Gutter	X Slope (%)	N/A		
N/A	Painted X Walk1?	No	N/A	Painte	d X Walk2?	N/A		
	X Walk 1 Direction	To S		X Wall	c 2 Direction	N/A		
N/A	X Walk 1 Width (in)	N/A	N/A	X Wall	c 2 Width (in)	N/A

X Walk 1 Slope (%)	1.8		X Wall	< 2 Slope (%)	N/A		
	X Walk 1 X Slope (%)	1.8		X Wall	< 2 X Slope (%)	N/A		
N/A	Ramp inside XWalk1?	N/A	N/A	Ramp	inside XWalk2?	N/A		
	Road Slope (%)	N/A	N/A	Clear	Space?	N/A		
	Road X Slope (%)	N/A	N/A	Clear	Space to XWalk (in)	N/A		
N/A	Any Obstructions?	N/A	N/A	Storm	Grate/Utility Hazard?	N/A		
	Obstruction Type			Storm	Grate/Utility Type			
		N/A				N/A		
			Yes	Surfac	e Condition? (G/P)	Good		
4

Possible Solution	
Possible Solutions:	Comp
Remove & Replace Entire Ramp.	N/A
	No
	N/A
	N/A
	N/A
	N/A
Surveyor Notes:	N/A
N/A	N/A
	N/A
	N/A
	N/A
PROW/ADA:	N/A
Not Found, R304.5.1	N/A
	N/A
	N/A
	N/A
