# Access Compliance Report

## Public Rights-of-Way

Intersection ID: 43362	Main Street: PROSPERITY_VIEW_DR	Cross Street: RIDGE_RD	Location: NE
ADA ID: C309C56573AF	Ramp Type: Perp	Initial Pass/Fail: Fail	Overall Compliance: No
Severity Score: 18.75			
Codes/Mitigation Info/Possible Solution		Field Measurements/Component Compliance

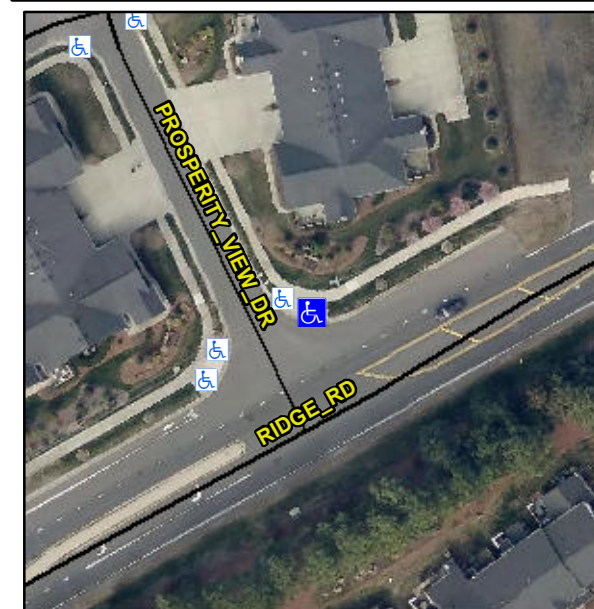
Compliance	Description	Data	Compliance	Description	Data
N/A	Ramp Length (in)	100.0	Yes	Ramp Slope (%)	7.5
No	Ramp Width (in)	35.5	No	Ramp XSlope (%)	2.1
N/A	Flare Type LT	N/A	N/A	Flare Type RT	N/A
N/A	Flare Slope LT (%)	N/A	N/A	Flare Slope RT (%)	N/A
N/A	Flare Traversable LT?	N/A	N/A	Flare Traversable RT?	N/A
N/A	Landing Length (in)	N/A	N/A	DWS Provided?	N/A
N/A	Landing Width (in)	N/A	N/A	DWS Contrast?	N/A
N/A	Landing Slope (%)	N/A	N/A	DWS Length (in)	N/A
N/A	Landing X Slope (%)	N/A	N/A	DWS Full Width?	N/A
N/A	Landing Curb? (Y/N)	N/A	N/A	DWS Offset (in)	N/A
N/A	Shared Landing?	N/A			
N/A	Gutter Ponding?	N/A	N/A	Gutter Slope (%)	N/A
N/A	Gutter Lip Ht (in)	N/A	N/A	Gutter X Slope (%)	N/A
N/A	Painted X Walk1?	No	N/A	Painted X Walk2?	N/A
	X Walk 1 Direction	To S		X Walk 2 Direction	N/A
N/A	X Walk 1 Width (in)	N/A	N/A	X Walk 2 Width (in)	N/A
	X Walk 1 Slope (%)	1.7		X Walk 2 Slope (%)	N/A
	X Walk 1 X Slope (%)	0.9		X Walk 2 X Slope (%)	N/A

**Remove & Replace Entire Ramp.**

**R304.5.1, R304.5.3**

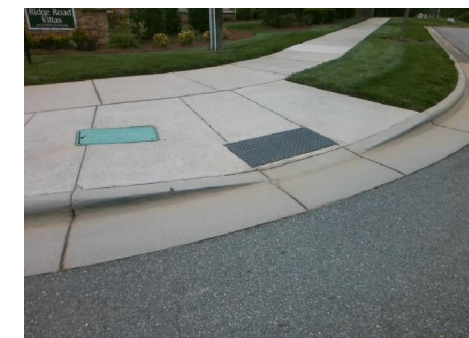
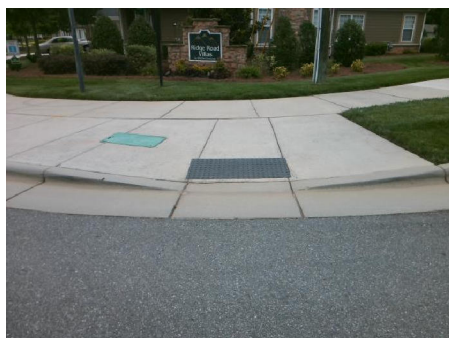
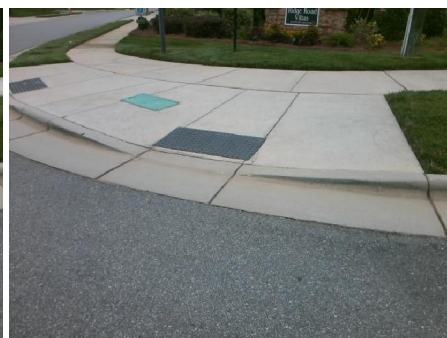
N/A	Ramp inside XWalk1?	N/A	N/A	Ramp inside XWalk2?	N/A
	Road Slope (%)	N/A	N/A	Clear Space?	N/A
	Road X Slope (%)	N/A	N/A	Clear Space to XWalk (in)	N/A
N/A	Any Obstructions?	N/A	N/A	Storm Grate/Utility Hazard?	N/A
	Obstruction Type			Storm Grate/Utility Type	
			N/A		N/A
			Yes	Surface Condition? (G/P)	Good
