# Access Compliance Report

## Public Rights-of-Way

### (Curb Ramps)

Intersection ID: 51794	Main Street: SUTTONVIEW_DR	Cross Street: BRADY_DR	Location: NW
ADA ID: C30C6E3FF8F6	Ramp Type: Perp	Initial Pass/Fail: Fail	Overall Compliance: No
			Severity Score: 21.25

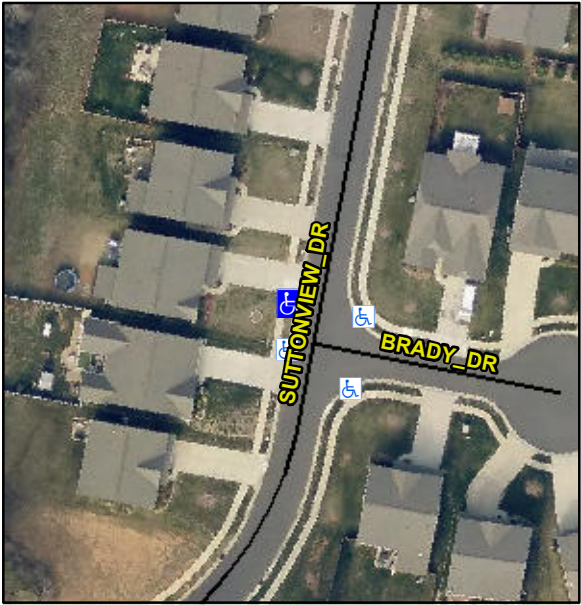
Possible Solutions:		<b>Compliance</b>	<b>Description</b>	<b>Data</b>
	<b>Remove &amp; Replace Entire Ramp.</b>		<b>No</b>	Ramp Length (in)	47.0
			<b>No</b>	Ramp Width (in)	47.0
			<b>N/A</b>	Flare Type LT	N/A
			<b>N/A</b>	Flare Slope LT (%)	N/A
			<b>N/A</b>	Flare Traversable LT?	N/A
			<b>N/A</b>	Landing Length (in)	N/A
			<b>N/A</b>	Landing Width (in)	N/A
			<b>N/A</b>	Landing Slope (%)	N/A
			<b>N/A</b>	Landing X Slope (%)	N/A
<p>Surveyor Notes:</p> <p><b>N/A</b></p> <p>PROW/ADA:</p> <p><b>Not Found, R304.5.1, R304.2.2</b></p>			<b>N/A</b>	Flare Type RT	N/A
			<b>N/A</b>	Flare Slope RT (%)	N/A
			<b>N/A</b>	Flare Traversable RT?	N/A
			<b>N/A</b>	DWS Provided?	N/A
			<b>N/A</b>	DWS Contrast?	N/A
			<b>N/A</b>	DWS Length (in)	N/A
			<b>N/A</b>	DWS Full Width?	N/A
			<b>N/A</b>	DWS Offset (in)	N/A
			<b>N/A</b>	Gutter Ponding?	N/A

<b>N/A</b>	Gutter Lip Ht (in)	N/A
			<b>No</b>	Painted X Walk1?	N/A
				X Walk 1 Direction	To E
			<b>N/A</b>	X Walk 1 Width (in)	N/A
				X Walk 1 Slope (%)	2.4
				X Walk 1 X Slope (%)	1.2
			<b>N/A</b>	Ramp inside XWalk1?	N/A
			<b>N/A</b>	Road Slope (%)	N/A
			<b>N/A</b>	Road X Slope (%)	N/A
			<b>N/A</b>	Any Obstructions?	N/A
				Obstruction Type	
Total Cost:		\$ 1850.00	<b>N/A</b>	Storm Grate/Utility Hazard?	N/A
			<b>N/A</b>	Storm Grate/Utility Type	N/A
			<b>Yes</b>	Surface Condition? (G/P)	Good
