Access Compliance Report

Public Rights-of-Way

(Curb Ramps)

Intersection ID: 44486	Main Street: NEWFIELD_ST	Cross Street: DARWICK_ST	Location: NE
ADA ID: C3174D475E19	Ramp Type: BlendTrans1	Initial Pass/Fail: Fail	Overall Compliance: No
		Severity Score: 10

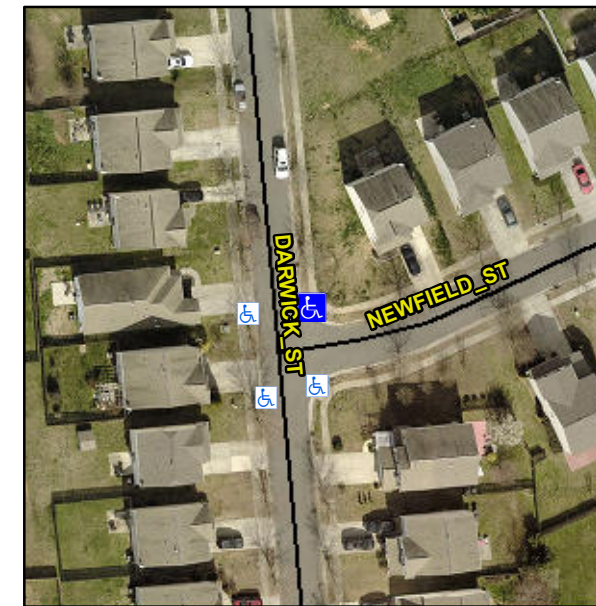
Not Found, R304.5.1, R304.5.3

Compliance	Description	Data	Compliance	Description	Data
N/A	Ramp Length (in)	47.0	Yes	BlendTrans Slope (%)	1.4
No	Ramp Width (in)	47.5	No	BlendTrans XSlope (%)	4.4
N/A	Flare Type LT	N/A	N/A	Flare Type RT	N/A
N/A	Flare Slope LT (%)	N/A	N/A	Flare Slope RT (%)	N/A
N/A	Flare Traversable LT?	N/A	N/A	Flare Traversable RT?	N/A
N/A	Landing Length (in)	N/A	N/A	DWS Provided?	N/A
N/A	Landing Width (in)	N/A	N/A	DWS Contrast?	N/A
N/A	Landing Slope (%)	N/A	N/A	DWS Length (in)	N/A
N/A	Landing X Slope (%)	N/A	N/A	DWS Full Width?	N/A
N/A	Landing Curb? (Y/N)	N/A	N/A	DWS Offset (in)	N/A
N/A	Shared Landing?	N/A			
N/A	Gutter Ponding?	N/A	N/A	Gutter Slope (%)	N/A
N/A	Gutter Lip Ht (in)	N/A	N/A	Gutter X Slope (%)	N/A
N/A	Painted X Walk1?	No	N/A	Painted X Walk2?	No
	X Walk 1 Direction	To W		X Walk 2 Direction	To S
	X Walk 1 Width (in)	N/A		X Walk 2 Width (in)	N/A
	X Walk 1 Slope (%)	2.4		X Walk 2 Slope (%)	0.7
	X Walk 1 X Slope (%)	1.9		X Walk 2 X Slope (%)	0.3

N/A	Ramp inside XWalk1?	N/A	N/A	Ramp inside XWalk2?	N/A
	Road Slope (%)	1.6		Clear Space?	N/A
	Road X Slope (%)	1.4	N/A	Clear Space to XWalk (in)	N/A
N/A	Any Obstructions?	N/A	N/A	Storm Grate/Utility Hazard?	N/A
	Obstruction Type			Storm Grate/Utility Type	
		N/A			N/A
			Yes	Surface Condition? (G/P)	Good
			No	Curb Slope (%)	15.9

Remove & Replace Curb Ramp With Two New Directional Ramps or Equivalent.
