Access Compliance Report

Public Rights-of-Way

(Curb Ramps)

Intersection ID: 11783	Main Street: N_GRAHAM_ST	Cross Street: W_5TH_ST	Location:	W
ADA ID: C3204015F67D	Ramp Type: PerpDiag	Initial Pass/Fail: Fail	Overall Compliance: No	Severity Score: 25

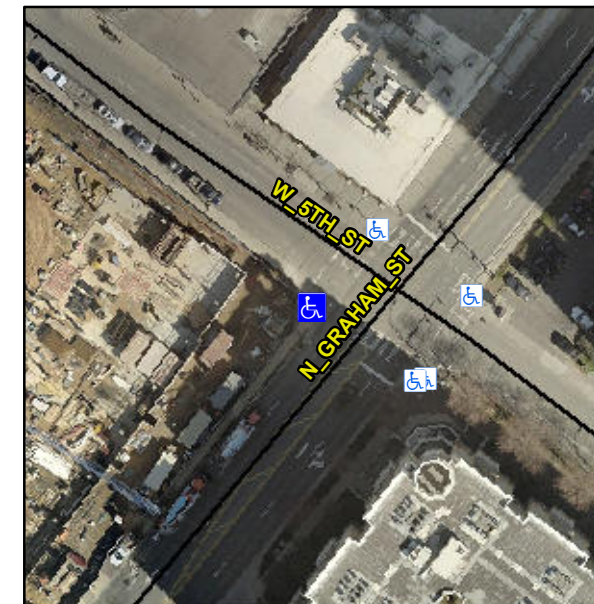
Compliance	Description	Data	Compliance	Description	Data
N/A	Ramp Length (in)	61.0	No	Ramp Slope (%)	9.2
Yes	Ramp Width (in)	58.0	No	Ramp XSlope (%)	6.0
N/A	Flare Type LT	N/A	N/A	Flare Type RT	N/A
N/A	Flare Slope LT (%)	N/A	N/A	Flare Slope RT (%)	N/A
N/A	Flare Traversable LT?	N/A	N/A	Flare Traversable RT?	N/A
N/A	Landing Length (in)	N/A	N/A	DWS Provided?	N/A
N/A	Landing Width (in)	N/A	N/A	DWS Contrast?	N/A
N/A	Landing Slope (%)	N/A	N/A	DWS Length (in)	N/A
N/A	Landing X Slope (%)	N/A	N/A	DWS Full Width?	N/A
N/A	Landing Curb? (Y/N)	N/A	N/A	DWS Offset (in)	N/A
N/A	Shared Landing?	N/A			
N/A	Gutter Ponding?	N/A	N/A	Gutter Slope (%)	N/A
N/A	Gutter Lip Ht (in)	N/A	N/A	Gutter X Slope (%)	N/A
N/A	Painted X Walk1?	Yes	N/A	Painted X Walk2?	Yes
	X Walk 1 Direction	To SE		X Walk 2 Direction	To NE
N/A	X Walk 1 Width (in)	100.0	N/A	X Walk 2 Width (in)	98.0
	X Walk 1 Slope (%)	3.0		X Walk 2 Slope (%)	2.2
	X Walk 1 X Slope (%)	1.1		X Walk 2 X Slope (%)	4.2

N/A	Ramp inside XWalk1?	Yes	N/A	Ramp inside XWalk2?	Yes
	Road Slope (%)	0.8	N/A	Clear Space?	N/A
	Road X Slope (%)	1.8	N/A	Clear Space to XWalk (in)	N/A
N/A	Any Obstructions?	N/A	N/A	Storm Grate/Utility Hazard?	N/A
	Obstruction Type			Storm Grate/Utility Type	
		N/A			N/A
		Yes		Surface Condition? (G/P)	Good

Remove & Replace Curb Ramp With Two New Directional Ramps or Equivalent.

R304.2.2, R304.5.3
