# Access Compliance Report

## Public Rights-of-Way

| Intersection ID: 47113 | Main Street: ELIZABETH_OAKS_AV | Cross Street: TINDLE_HILL_LN | Location: S |
| ADA ID: C32B3125B08C | Ramp Type: PerpDiag | Initial Pass/Fail: Fail | Overall Compliance: No |

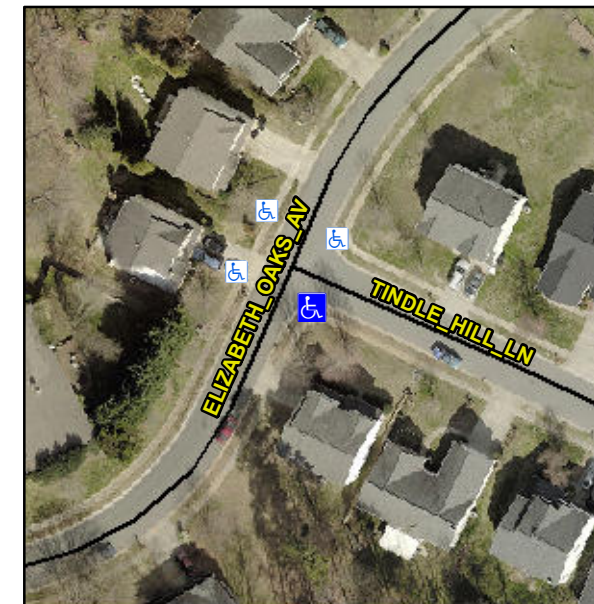
**Not Found, R304.5.1, R304.2.2, R304.5.3, R302.7**

| Compliance | Description | Data | Compliance | Description | Data |
|---|---|---|---|---|---|
| N/A | Ramp Length (in) | 46.5 | No | Ramp Slope (%) | 10.8 |
| No | Ramp Width (in) | 47.0 | No | Ramp XSlope (%) | 10.5 |
| | | No | | Surface Condition? (G/P) | Poor |

**Remove & Replace Curb Ramp With Two New Directional Ramps or Equivalent.**

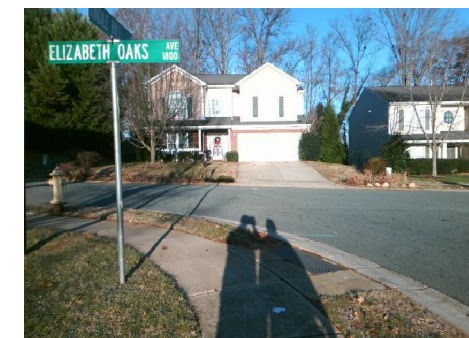
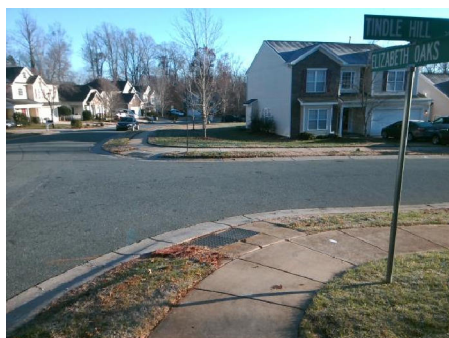
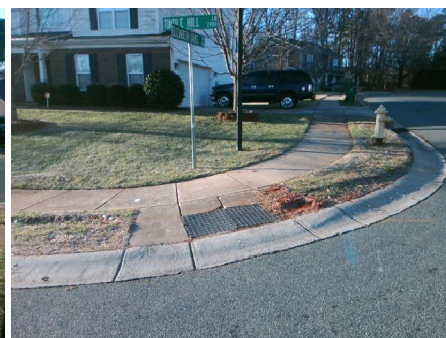
Street 1 Name TINDLE HILL LN  
 Stop Condition-Street 2 StopSign  
 Street 2 Name ELIZABETH OAKS AV  
 Stop Condition-Street 1 None

| Severity Score: 61.25 | | | |
