Access Compliance Report

Public Rights-of-Way

(Curb Ramps)

Intersection ID: 20969	Main Street: OLD_REID_RD	Cross Street: PARK_RD	Location: SE
ADA ID: C339CA9F4741	Ramp Type: PerpDiag	Initial Pass/Fail: Fail	Overall Compliance: No
		Severity Score: 12.5

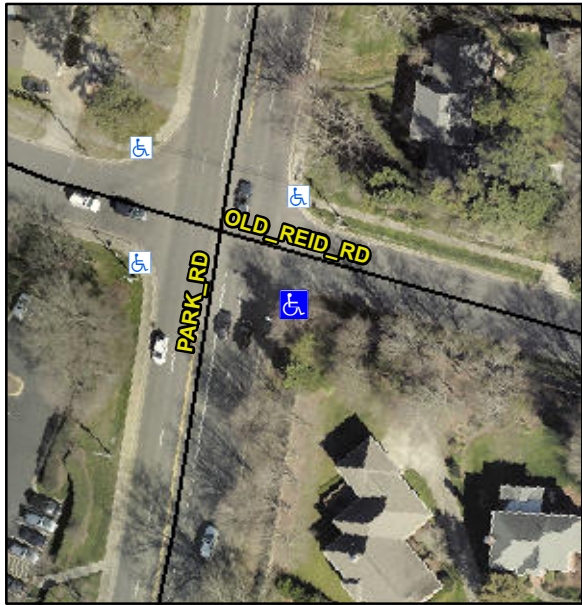
Possible Solutions:		Compliance	Description	Data	Compliance	Description	Data
	Remove & Replace Curb Ramp With Two New Directional Ramps or Equivalent.		N/A	Ramp Length (in)	83.0	Yes	Ramp Slope (%)	5.7
			Yes	Ramp Width (in)	48.0	No	Ramp XSlope (%)	5.2
			N/A	Flare Type LT	N/A	N/A	Flare Type RT	N/A
			N/A	Flare Slope LT (%)	N/A	N/A	Flare Slope RT (%)	N/A
			N/A	Flare Traversable LT?	N/A	N/A	Flare Traversable RT?	N/A
			N/A	Landing Length (in)	N/A	N/A	DWS Provided?	N/A
			N/A	Landing Width (in)	N/A	N/A	DWS Contrast?	N/A
			N/A	Landing Slope (%)	N/A	N/A	DWS Length (in)	N/A
			N/A	Landing X Slope (%)	N/A	N/A	DWS Full Width?	N/A
Surveyor Notes:		N/A	N/A	Landing Curb? (Y/N)	N/A	N/A	DWS Offset (in)	N/A
			N/A	Shared Landing?	N/A			
PROW/ADA:		Not Found, R304.5.3	N/A	Gutter Ponding?	N/A	N/A	Gutter Slope (%)	N/A
			N/A	Gutter Lip Ht (in)	0.5	N/A	Gutter X Slope (%)	N/A
