Access Compliance Report

Public Rights-of-Way

(Curb Ramps)

Intersection ID: 29178	Main Street: HARRIS_CENTER_DR	Cross Street: STATESVILLE_RD	Location: W
ADA ID: C34C3D75926B	Ramp Type: Perp	Initial Pass/Fail: Fail	Overall Compliance: No
Severity Score: 25			
Codes/Mitigation Info/Possible Solution		Field Measurements/Component Compliance

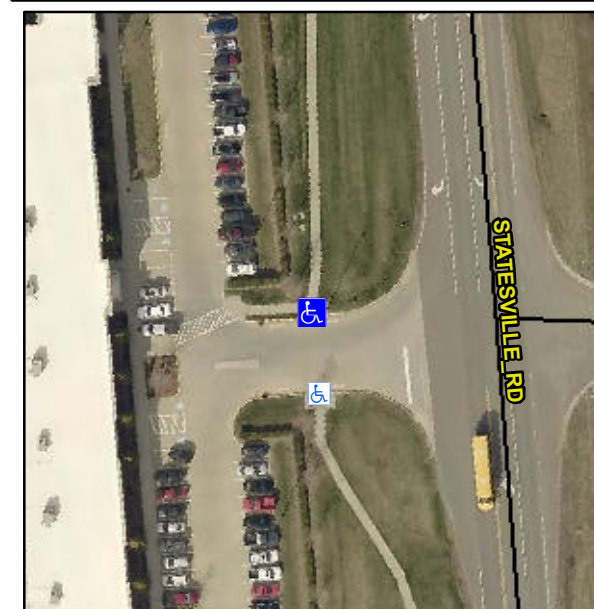
R304.2.2, R304.5.3

Compliance	Description	Data	Compliance	Description	Data
N/A	Ramp Length (in)	96.0	No	Ramp Slope (%)	9.4
Yes	Ramp Width (in)	48.0	No	Ramp XSlope (%)	5.6
N/A	Flare Type LT	N/A	N/A	Flare Type RT	N/A
N/A	Flare Slope LT (%)	N/A	N/A	Flare Slope RT (%)	N/A
N/A	Flare Traversable LT?	N/A	N/A	Flare Traversable RT?	N/A
N/A	Landing Length (in)	N/A	N/A	DWS Provided?	N/A
N/A	Landing Width (in)	N/A	N/A	DWS Contrast?	N/A
N/A	Landing Slope (%)	N/A	N/A	DWS Length (in)	N/A
N/A	Landing X Slope (%)	N/A	N/A	DWS Full Width?	N/A
N/A	Landing Curb? (Y/N)	N/A	N/A	DWS Offset (in)	N/A
N/A	Shared Landing?	N/A			
N/A	Gutter Ponding?	N/A	N/A	Gutter Slope (%)	N/A
N/A	Gutter Lip Ht (in)	0.5	N/A	Gutter X Slope (%)	N/A
N/A	Painted X Walk1?	No	N/A	Painted X Walk2?	N/A
	X Walk 1 Direction	To S		X Walk 2 Direction	N/A
N/A	X Walk 1 Width (in)	N/A	N/A	X Walk 2 Width (in)	N/A
	X Walk 1 Slope (%)	2.4		X Walk 2 Slope (%)	N/A
	X Walk 1 X Slope (%)	5.9		X Walk 2 X Slope (%)	N/A

N/A	Ramp inside XWalk1?	N/A	N/A	Ramp inside XWalk2?	N/A
	Road Slope (%)	N/A	N/A	Clear Space?	N/A
	Road X Slope (%)	N/A	N/A	Clear Space to XWalk (in)	N/A
N/A	Any Obstructions?	N/A	N/A	Storm Grate/Utility Hazard?	N/A
	Obstruction Type			Storm Grate/Utility Type	
		N/A			N/A
		Yes		Surface Condition? (G/P)	Good

Possible Solutions:

Remove & Replace Entire Ramp.
