Access Compliance Report Public Rights-of-Way (Curb Ramps)

Intersection ID: 14314 Main Street: TREMONT_ST Cross Street: SOUTH_BV Location: S

ADA ID: C36D75E8B08D Ramp Type: PerpDiag Initial Pass/Fail: Fail Overall Compliance: No Severity Score: 37.5

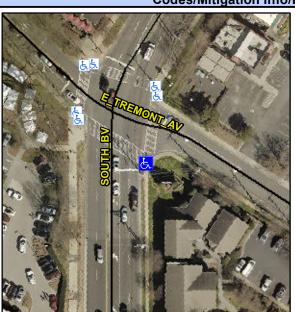
Comp	liance Description	Data	Comp	liance	Description	Data
N/A	Ramp Length (in)	57.0	No	Ramp	Slope (%)	9.4
Yes	Ramp Width (in)	125.0	No	Ramp	XSlope (%)	8.4
N/A	Flare Type LT	N/A	N/A	Flare	Type RT	N/A
N/A	Flare Slope LT (%)	N/A	N/A	Flare	Slope RT (%)	N/A
N/A	Flare Traversable LT?	N/A	N/A	Flare	Traversable RT?	N/A
N/A	Landing Length (in)	N/A	N/A	DWS	Provided?	N/A
N/A	Landing Width (in)	N/A	N/A	DWS	Contrast?	N/A
N/A	Landing Slope (%)	N/A	N/A	DWS	Length (in)	N/A
N/A	Landing X Slope (%)	N/A	N/A	DWS	Full Width?	N/A
N/A	Landing Curb? (Y/N)	N/A	N/A	DWS	Offset (in)	N/A
N/A	Shared Landing?	N/A				
N/A	Gutter Ponding?	N/A	N/A	Gutte	r Slope (%)	N/A
N/A	Gutter Lip Ht (in)	N/A	N/A	Gutte	r X Slope (%)	N/A
N/A	Painted X Walk1?	Yes	N/A	Painte	ed X Walk2?	Yes
	X Walk 1 Direction	To NE		X Wa	lk 2 Direction	To NW
N/A	X Walk 1 Width (in)	120.0	N/A	X Wa	lk 2 Width (in)	158.0
	X Walk 1 Slope (%)	5.9		X Wa	lk 2 Slope (%)	3.3
	X Walk 1 X Slope (%)	10.2		X Wa	lk 2 X Slope (%)	3.5

N/A	Ramp inside XWalk1?	Yes	N/A	Ramp	inside XWalk2?	Yes
	Road Slope (%)	7.0	N/A	Clear	Space?	N/A
	Road X Slope (%)	4.3	N/A	Clear	Space to XWalk (in)	N/A
N/A	Any Obstructions?	N/A	N/A	Storm	Grate/Utility Hazard?	N/A
	Obstruction Type			Storm	Grate/Utility Type	
		N/A				N/A

Remove & Replace Curb Ramp With
Two New Directional Ramps or
Equivalent.

R304.2.2, R304.5.3
