## Access Compliance Report Public Rights-of-Way (Curb Ramps)

Intersection ID: 13384Main Street: S\_MINT\_STCross Street: W\_PARK\_AVLocation:NWADA ID: C36EB9B2ED0DRamp Type: ParaInitial Pass/Fail: FailOverall Compliance: NoSeverity Score: 13.75

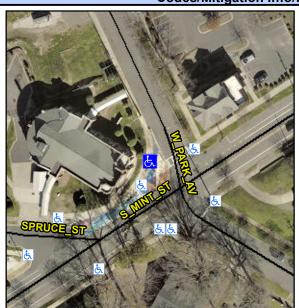
Comp	liance Description	Data	Comp	liance Description	Data
N/A	Ramp Length LT (in)	64.0	N/A	Ramp Length RT (in)	224.0
Yes	Ramp Width LT (in)	73.0	Yes	Ramp Width RT (in)	60.0
Yes	Ramp Slope LT (%)	2.1	Yes	Ramp Slope RT (%)	8.5
No	Ramp XSlope LT (%)	2.2	No	Ramp XSlope RT (%)	2.1
N/A	Landing Length (in)	N/A	N/A	DWS Provided?	N/A
N/A	Landing Width (in)	N/A	N/A	DWS Contrast?	N/A
N/A	Landing Slope (%)	N/A	N/A	DWS Length (in)	N/A
N/A	Landing X Slope (%)	N/A	N/A	DWS Full Width?	N/A
N/A	Landing Curb? (Y/N)	N/A	N/A	DWS Offset (in)	N/A
N/A	Shared Landing?	N/A			
N/A	Gutter Ponding?	N/A	N/A	Gutter Slope (%)	N/A
N/A	Gutter Lip Ht (in)	N/A	N/A	Gutter X Slope (%)	N/A
N/A	Painted X Walk1?	No	N/A	Painted X Walk2?	N/A
	X Walk 1 Direction	To NE		X Walk 2 Direction	N/A
N/A	X Walk 1 Width (in)	N/A	N/A	X Walk 2 Width (in)	N/A
	X Walk 1 Slope (%)	9.5		X Walk 2 Slope (%)	N/A
	X Walk 1 X Slope (%)	1.7		X Walk 2 X Slope (%)	N/A
N/A	Ramp inside XWalk1?	N/A	N/A	Ramp inside XWalk2?	N/A

Road Slope (%)	N/A	N/A	Clear Space?	N/A
	Road X Slope (%)	N/A	N/A	Clear Space to XWalk (in)	N/A
N/A	Any Obstructions?	N/A	N/A	Storm Grate/Utility Hazard?	N/A
	Obstruction Type			Storm Grate/Utility Type	
		N/A			N/A
			Yes	Surface Condition? (G/P)	Good
			N/A	Curb Slope (%)	6.5

Possible Solution	
Possible Solutions:	Compl
Remove & Replace Entire Ramp.	N/A
·	Yes
	Yes
	No
	N/A
	N/A
Surveyor Notes:	N/A
LT RP < 5%	N/A
	N/A
	N/A
	N/A
PROW/ADA:	N/A
R304.5.3	N/A
	N/A
	N/A

Total Cost: \$ 1600.00
