Access Compliance Report Public Rights-of-Way (Curb Ramps)

Intersection ID: 25995Main Street: WEDDINGTON_RDCross Street: PLANTATION_CENTER_DRLocation: NWADA ID: C36F46EF2C91Ramp Type: ParaInitial Pass/Fail: Fail Overall Compliance: No Severity Score: 12.5

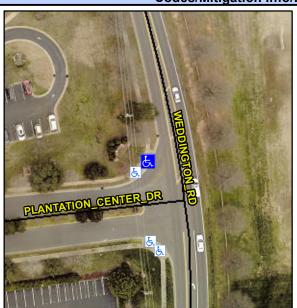
Compliance Description		Data	Compliance Description		Data
N/A	Ramp Length LT (in)	60.0	N/A	Ramp Length RT (in)	68.0
Yes	Ramp Width LT (in)	96.0	Yes	Ramp Width RT (in)	96.0
No	Ramp Slope LT (%)	8.7	No	Ramp Slope RT (%)	9.4
Yes	Ramp XSlope LT (%)	1.4	Yes	Ramp XSlope RT (%)	1.6
N/A	Landing Length (in)	N/A	N/A	DWS Provided?	N/A
N/A	Landing Width (in)	N/A	N/A	DWS Contrast?	N/A
N/A	Landing Slope (%)	N/A	N/A	DWS Length (in)	N/A
N/A	Landing X Slope (%)	N/A	N/A	DWS Full Width?	N/A
N/A	Landing Curb? (Y/N)	N/A	N/A	DWS Offset (in)	N/A
N/A	Shared Landing?	N/A			
N/A	Gutter Ponding?	N/A	N/A	Gutter Slope (%)	N/A
N/A	Gutter Lip Ht (in)	N/A	N/A	Gutter X Slope (%)	N/A
N/A	Painted X Walk1?	No	N/A	Painted X Walk2?	N/A
	X Walk 1 Direction	To NE		X Walk 2 Direction	N/A
N/A	X Walk 1 Width (in)	N/A	N/A	X Walk 2 Width (in)	N/A
	X Walk 1 Slope (%)	0.7		X Walk 2 Slope (%)	N/A
	X Walk 1 X Slope (%)	1.2		X Walk 2 X Slope (%)	N/A
N/A	Ramp inside XWalk1?	N/A	N/A	Ramp inside XWalk2?	N/A

Road Slope (%)	N/A	N/A	Clear Space?	N/A
	Road X Slope (%)	N/A	N/A	Clear Space to XWalk (in)	N/A
N/A	Any Obstructions?	N/A	N/A	Storm Grate/Utility Hazard?	N/A
	Obstruction Type			Storm Grate/Utility Type	
		N/A			N/A
			Yes	Surface Condition? (G/P)	Good
			N/A	Curb Slope (%)	7.6

Possible Solution	
Possible Solutions:	Co
Remove & Replace Entire Ramp.	N/A
·	Ye
	No
	Ye
	N/A
	N/A
Surveyor Notes:	N/A
N/A	N/A
	N/A
	N/A
	N/A
PROW/ADA:	N/A
R304.3.2	N/A
	N/A
	N/A

Total Cost:	\$	1600.00
	т -
