Access Compliance Report

Public Rights-of-Way

(Curb Ramps)

| Intersection ID: 49382 | Main Street: SOUTH_DEVON_ST | Cross Street: ROCKY_RIVER_RD | Location: SW |

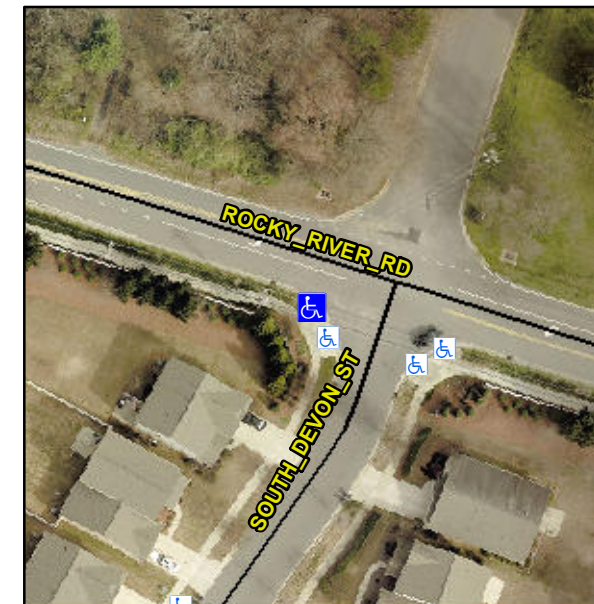
| ADA ID: C37B46204EEC | Ramp Type: Perp | Initial Pass/Fail: Fail | Overall Compliance: No |
| Severity Score: 8.75 | | | |

R304.5.1

| Compliance | Description | Data | Compliance | Description | Data |
|---|---|---|---|---|---|
| No | Ramp Width (in) | 47.5 | Yes | Ramp XSlope (%) | 1.7 |

Possible Solutions:

Remove & Replace Entire Ramp.

Total Cost:

\$ 1850.00
