Access Compliance Report Public Rights-of-Way (Curb Ramps)

Intersection ID: 49277 Main Street: REUNION ST **Cross Street: HOMECOMING WY** Location: NE **Overall Compliance: No ADA ID: C3891D7FE07F** Ramp Type: PerpDiag Initial Pass/Fail: Fail Severity Score: 13.75

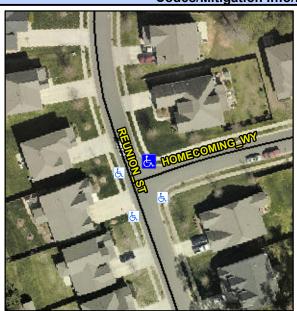
R304.2.2, R304.5.3 Total Cost: 3200.00 Compliance Description Data Compliance Description Data No N/A Ramp Length (in) 47.5 Ramp Slope (%) 9.9 No Ramp XSlope (%) Yes Ramp Width (in) 48.0 4.9 N/A N/A Flare Type LT N/A Flare Type RT N/A N/A N/A N/A Flare Slope RT (%) N/A Flare Slope LT (%) N/A Flare Traversable LT? N/A N/A Flare Traversable RT? N/A N/A N/A N/A **DWS Provided?** N/A Landing Length (in) N/A Landing Width (in) N/A N/A **DWS Contrast?** N/A N/A N/A N/A Landing Slope (%) DWS Length (in) N/A N/A Landing X Slope (%) N/A N/A DWS Full Width? N/A N/A Landing Curb? (Y/N) N/A N/A DWS Offset (in) N/A N/A N/A Shared Landing? N/A **Gutter Ponding?** N/A N/A Gutter Slope (%) N/A N/A Gutter Lip Ht (in) N/A N/A Gutter X Slope (%) N/A N/A Painted X Walk1? No N/A Painted X Walk2? No X Walk 1 Direction To W X Walk 2 Direction To S N/A N/A N/A X Walk 2 Width (in) X Walk 1 Width (in) N/A X Walk 1 Slope (%) 1.6 X Walk 2 Slope (%) 4.9 X Walk 1 X Slope (%) 5.4 X Walk 2 X Slope (%) 4.2 N/A N/A N/A Ramp inside XWalk2? N/A Ramp inside XWalk1? Road Slope (%) 4.7 N/A Clear Space? N/A N/A Road X Slope (%) 3.1 Clear Space to XWalk (in) N/A N/A N/A N/A Any Obstructions? Storm Grate/Utility Hazard? N/A **Obstruction Type** Storm Grate/Utility Type N/A N/A Yes Surface Condition? (G/P) Good

REUNION ST Street 1 Name Stop Condition-Street 2 None **HOMECOMING WY** Street 2 Name Stop Condition-Street 1 StopSign Possible Solutions: Remove & Replace Curb Ramp With Two New Directional Ramps or Equivalent. Surveyor Notes: N/A PROW/ADA:
