# Access Compliance Report

## Public Rights-of-Way

### (Curb Ramps)

Intersection ID: 20287	Main Street: SOUTH_BV	Cross Street: WICKER_DR	Location: NE
ADA ID: C390CEF16A93	Ramp Type: PerpDiag	Initial Pass/Fail: Fail	Overall Compliance: No
		Severity Score: 10

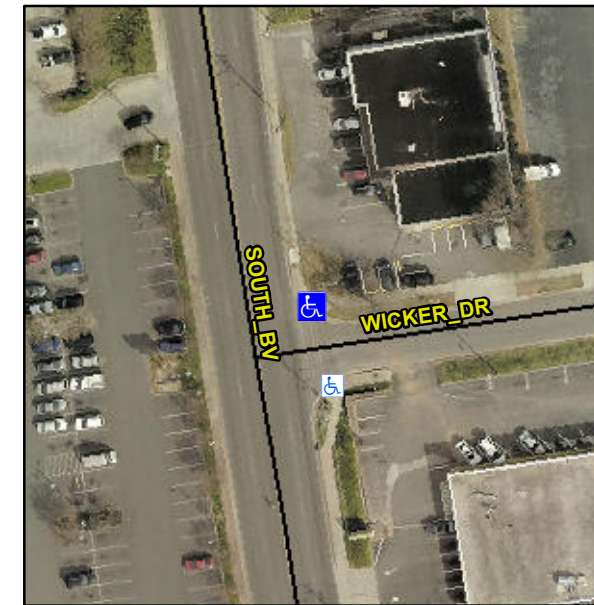
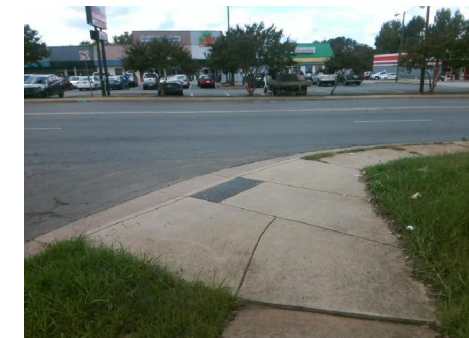
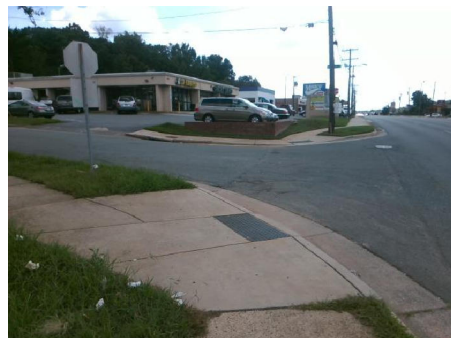
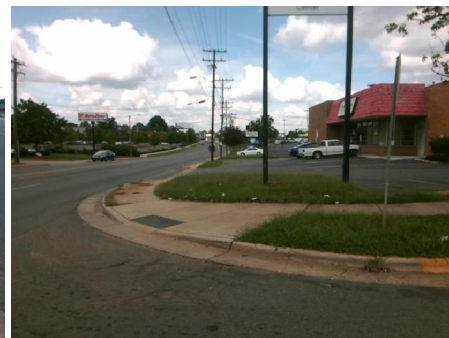
**Not Found, R304.5.1, R304.5.3**

Compliance	Description	Data	Compliance	Description	Data
N/A	Ramp Length (in)	98.0	Yes	Ramp Slope (%)	5.3
No	Ramp Width (in)	47.0	No	Ramp XSlope (%)	2.3
N/A	Flare Type LT	N/A	N/A	Flare Type RT	N/A
N/A	Flare Slope LT (%)	N/A	N/A	Flare Slope RT (%)	N/A
N/A	Flare Traversable LT?	N/A	N/A	Flare Traversable RT?	N/A
N/A	Landing Length (in)	N/A	N/A	DWS Provided?	N/A
N/A	Landing Width (in)	N/A	N/A	DWS Contrast?	N/A
N/A	Landing Slope (%)	N/A	N/A	DWS Length (in)	N/A
N/A	Landing X Slope (%)	N/A	N/A	DWS Full Width?	N/A
N/A	Landing Curb? (Y/N)	N/A	N/A	DWS Offset (in)	N/A
N/A	Shared Landing?	N/A			
N/A	Gutter Ponding?	N/A	N/A	Gutter Slope (%)	N/A
N/A	Gutter Lip Ht (in)	N/A	N/A	Gutter X Slope (%)	N/A
N/A	Painted X Walk1?	No	N/A	Painted X Walk2?	No
	X Walk 1 Direction	To W		X Walk 2 Direction	To S
N/A	X Walk 1 Width (in)	N/A	N/A	X Walk 2 Width (in)	N/A
	X Walk 1 Slope (%)	1.5		X Walk 2 Slope (%)	1.1
	X Walk 1 X Slope (%)	0.2		X Walk 2 X Slope (%)	0.5

N/A	Ramp inside XWalk1?	N/A	N/A	Ramp inside XWalk2?	N/A
	Road Slope (%)	0.8	N/A	Clear Space?	N/A
	Road X Slope (%)	2.4	N/A	Clear Space to XWalk (in)	N/A
N/A	Any Obstructions?	N/A	N/A	Storm Grate/Utility Hazard?	N/A
	Obstruction Type			Storm Grate/Utility Type	
		N/A			N/A
		Yes		Surface Condition? (G/P)	Good

**Remove & Replace Curb Ramp With Two New Directional Ramps or Equivalent.**
