Access Compliance Report

Public Rights-of-Way

(Curb Ramps)

| Intersection ID: 53230 | Main Street: MORGAN_CLARK_RD | Cross Street: EVERGREEN_DR | Location: NW |

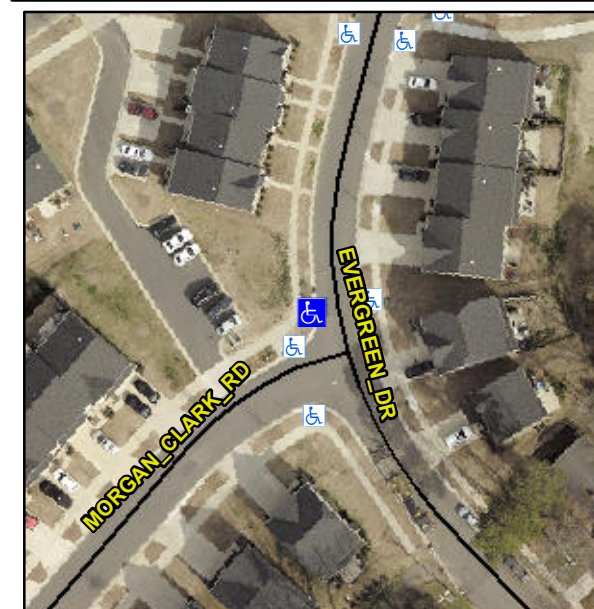
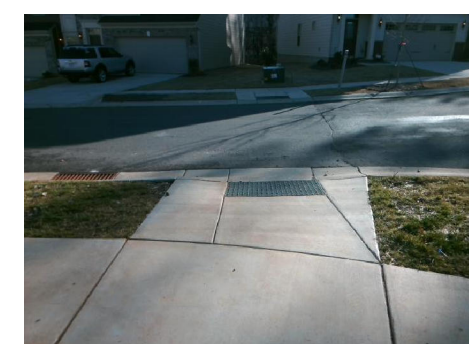
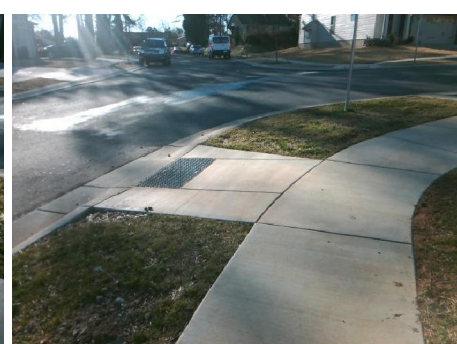
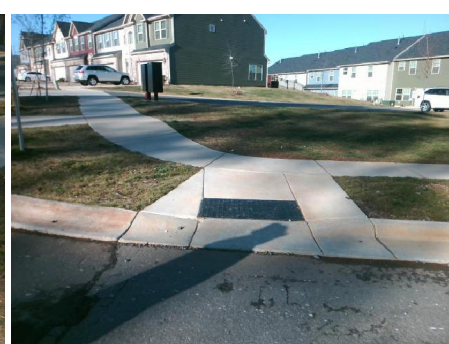
Not Found, R304.2.2

| Compliance | Description | Data | Compliance | Description | Data |
|---|---|---|---|---|---|
| N/A | Ramp Length (in) | 72.0 | No | Ramp Slope (%) | 9.3 |

Possible Solutions:

Remove & Replace Entire Ramp.
