# Access Compliance Report

## Public Rights-of-Way

| Intersection ID: 22153 | Main Street: PUDDINGSTONE CV | Cross Street: STOCKTIE RD | Location: | N |
| ADA ID: C39E390D9B43 | Ramp Type: BlendTrans1 | Initial Pass/Fail: Fail | Overall Compliance: No | Severity Score: 10 |

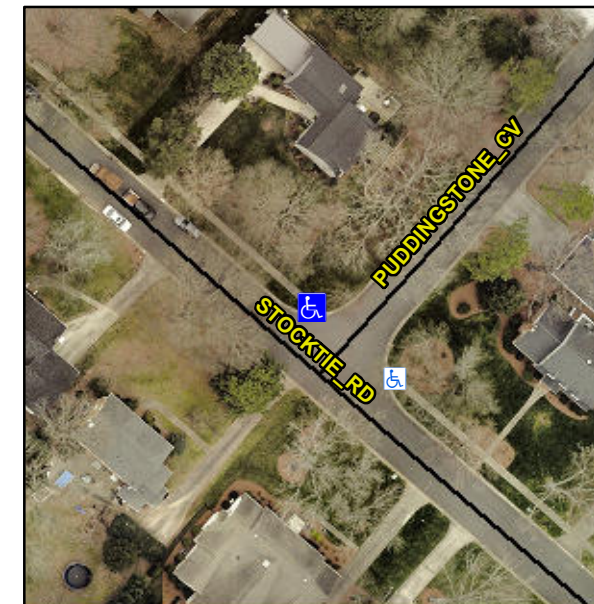
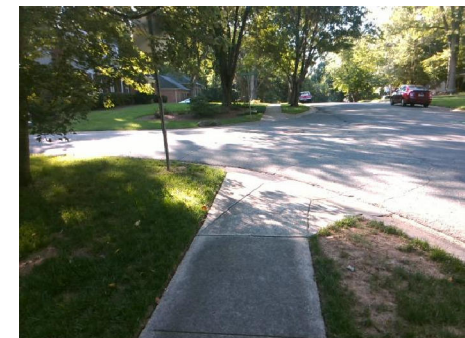
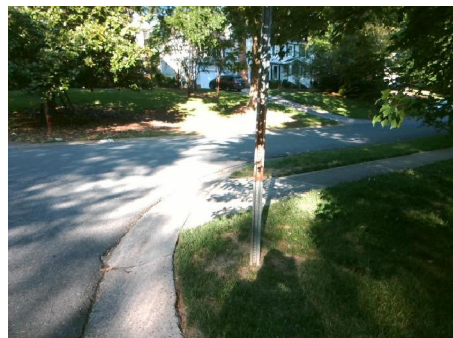
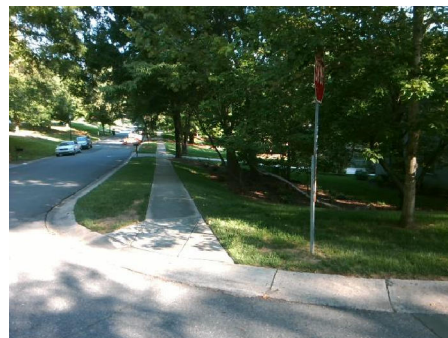
**Not Found, R304.5.1, R304.5.3**

| Compliance | Description | Data | Compliance | Description | Data |
|---|---|---|---|---|---|
| No | Ramp Width (in) | 37.0 | No | BlendTrans XSlope (%) | 4.5 |

**Remove & Replace Curb Ramp With Two New Directional Ramps or Equivalent.**
