# Access Compliance Report

## Public Rights-of-Way

### (Curb Ramps)

| Intersection ID: 10725 | Main Street: N_TRYON_ST | Cross Street: KESWICK_AV | Location: NW |

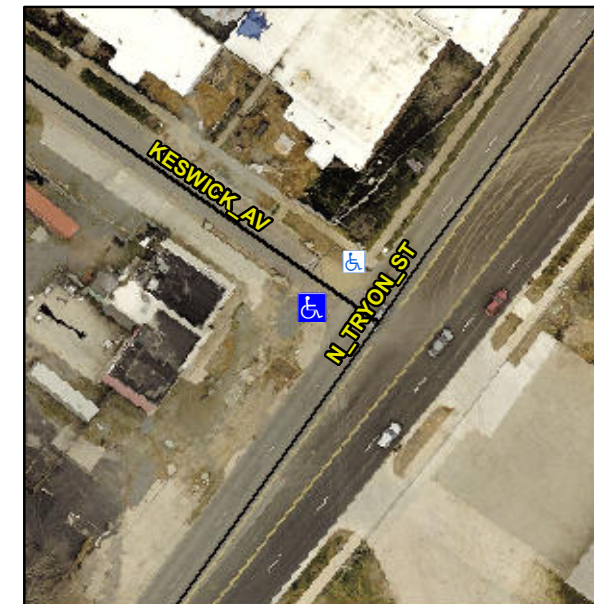
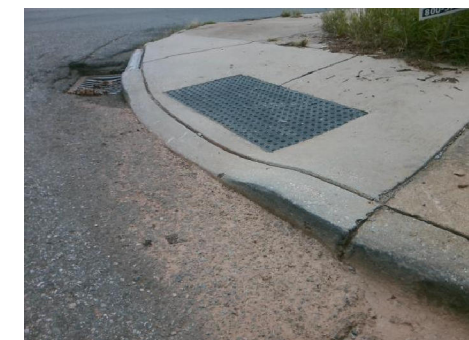
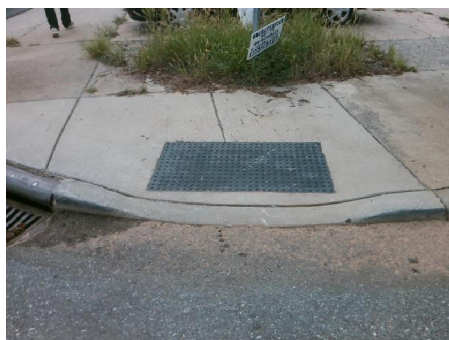
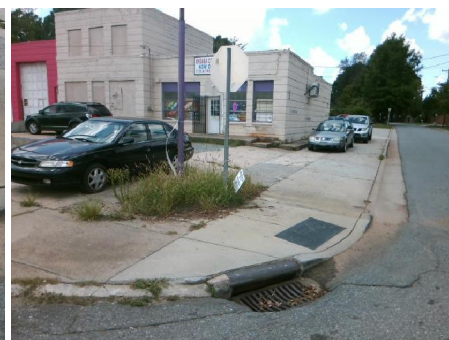
**Not Found, R304.5.1, R304.2.2**

| Compliance | Description | Data | Compliance | Description | Data |
|---|---|---|---|---|---|
| N/A | Ramp Length (in) | 29.5 | No | Ramp Slope (%) | 9.9 |
| No | Ramp Width (in) | 46.0 | Yes | Ramp XSlope (%) | 1.6 |

**Remove & Replace Entire Ramp.**
