Access Compliance Report

Public Rights-of-Way

Intersection ID: 14585		Main Street: RUBINE_ST		Cross Street: W_TYVOLA_RD		Location: SE			
ADA ID: C3B0AED7D4E4		Ramp Type: Directional1		Initial Pass/Fail: Pass		Overall Compliance: No		Severity Score: 2.5	
Codes/Mitigation Info/Possible Solution				Field Measurements/Component Compliance

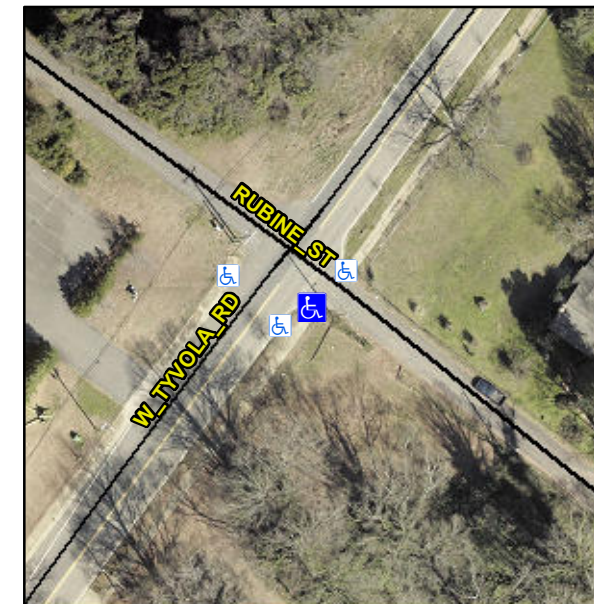
Compliance	Description	Data	Compliance	Description	Data
N/A	Ramp Length (in)	64.0	Yes	Grade Break?	Yes
Yes	Ramp Width (in)	60.0	Yes	Grade Break Slope (%)	3.3
Yes	Ramp Slope (%)	4.8	Yes	Grade Break XSlope (%)	0.9
Yes	Ramp XSlope (%)	1.7			
Yes	Flare Type LT	N/A	Yes	Flare Type RT	N/A
N/A	Flare Slope LT (%)	N/A	N/A	Flare Slope RT (%)	N/A
N/A	Flare Traversable LT?	No	N/A	Flare Traversable RT?	No
Yes	Landing Length (in)	53.5	Yes	DWS Provided?	Yes
Yes	Landing Width (in)	64.0	Yes	DWS Contrast?	Yes
Yes	Landing Slope (%)	1.2	Yes	DWS Length (in)	24.0
Yes	Landing X Slope (%)	0.9	No	DWS Full Width?	No
N/A	Landing Curb? (Y/N)	No	Yes	DWS Offset LT (in)	31.0
N/A	Shared Landing?	No	No	DWS Offset RT (in)	12.0
Yes	Gutter Ponding?	No	Yes	Gutter Slope (%)	0.4
Yes	Gutter Lip Ht (in)	0.0	Yes	Gutter X Slope (%)	0.5
N/A	Painted X Walk1?	No		Road Slope (%)	2.0
	X Walk 1 Direction	To NE		Road X Slope (%)	0.0
	X Walk 1 Width (in)	N/A		Clear Space?	Yes

X Walk 1 Slope (%)	2.0	N/A	Clear Space to XWalk (in)	N/A
	X Walk 1 X Slope (%)	0.0	Yes	Storm Grate/Utility Hazard?	No
N/A	Ramp inside XWalk1?	N/A		Storm Grate/Utility Type	
Yes	Any Obstructions?	No			N/A
	Obstruction Type		Yes	Surface Condition? (G/P)	Good
			N/A	Curb Slope (%)	2.3

Remove & Replace Detectable Warning System.

R305.1.4, R305.2

\$ 800.00
