# Access Compliance Report

## Public Rights-of-Way

### (Curb Ramps)

| Intersection ID: 12809 | Main Street: N_MCDOWELL_ST | Cross Street: E_7TH_ST | Location: E |

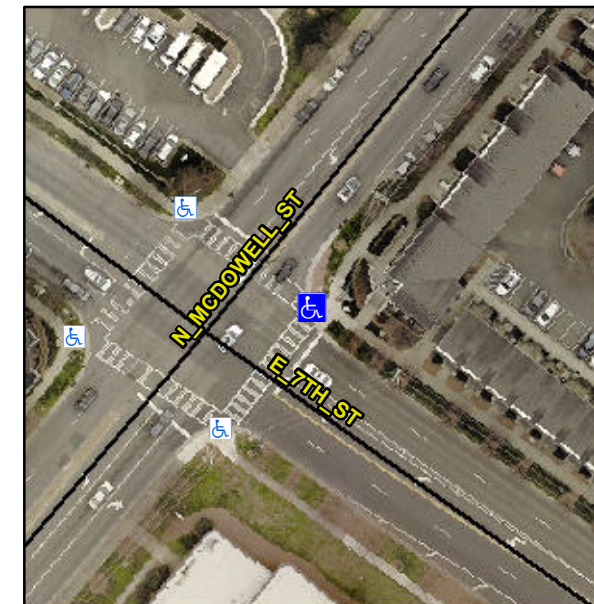
| ADA ID: C3B19F6E9755 | Ramp Type: PerpDiag | Initial Pass/Fail: Fail | Overall Compliance: No |
| Severity Score: 37.5 | | | |

**Not Found, R304.2.2, R304.5.3**

| Compliance | Description | Data | Compliance | Description | Data |
|---|---|---|---|---|---|
| N/A | Ramp Length (in) | 103.0 | No | Ramp Slope (%) | 10.2 |
| Yes | Ramp Width (in) | 93.5 | No | Ramp XSlope (%) | 13.2 |

**Remove & Replace Curb Ramp With Two New Directional Ramps or Equivalent.**

Total Cost: \$ 3200.00
