# Access Compliance Report

## Public Rights-of-Way

### (Curb Ramps)

Intersection ID: 28945	Main Street: CRESCENT_VIEW_DR	Cross Street: MALLARD_CREEK_RD	Location: SE
ADA ID: C3B2CDE704E9	Ramp Type: Combination2	Initial Pass/Fail: Fail	Overall Compliance: No
Severity Score: 13.75			
Codes/Mitigation Info/Possible Solution		Field Measurements/Component Compliance

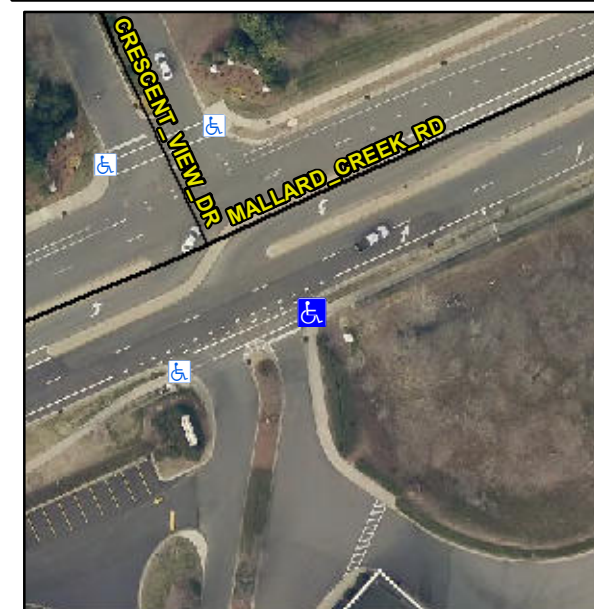
**R304.5.1, R304.5.1, R304.5.3,  
R304.3.2**

Compliance	Description	Data	Compliance	Description	Data
N/A	Ramp Length LT (in)	N/A	N/A	Ramp Length RT (in)	62.5
N/A	Ramp Width LT (in)	N/A	No	Ramp Width RT (in)	42.0
N/A	Ramp Slope LT (%)	N/A	No	Ramp Slope RT (%)	10.2
N/A	Ramp XSlope LT (%)	N/A	No	Ramp XSlope RT (%)	2.2
N/A	Ramp Length (in)	53.0	Yes	Ramp Slope (%)	5.7
No	Ramp Width (in)	34.0	No	Ramp XSlope (%)	3.8
N/A	Flare Type LT	N/A	N/A	Flare Type RT	N/A
N/A	Flare Slope LT (%)	N/A	N/A	Flare Slope RT (%)	N/A
N/A	Flare Traversable LT?	N/A	N/A	Flare Traversable RT?	N/A
N/A	Landing Length (in)	N/A	N/A	DWS Provided?	N/A
N/A	Landing Width (in)	N/A	N/A	DWS Contrast?	N/A
N/A	Landing Slope (%)	N/A	N/A	DWS Length (in)	N/A
N/A	Landing X Slope (%)	N/A	N/A	DWS Full Width?	N/A
N/A	Landing Curb? (Y/N)	N/A	N/A	DWS Offset (in)	N/A
N/A	Shared Landing?	N/A			
N/A	Gutter Ponding?	N/A	N/A	Gutter Slope (%)	N/A
N/A	Gutter Lip Ht (in)	N/A	N/A	Gutter X Slope (%)	N/A
N/A	Painted X Walk1?	Yes	N/A	Painted X Walk2?	N/A

**Remove & Replace Entire Ramp.**

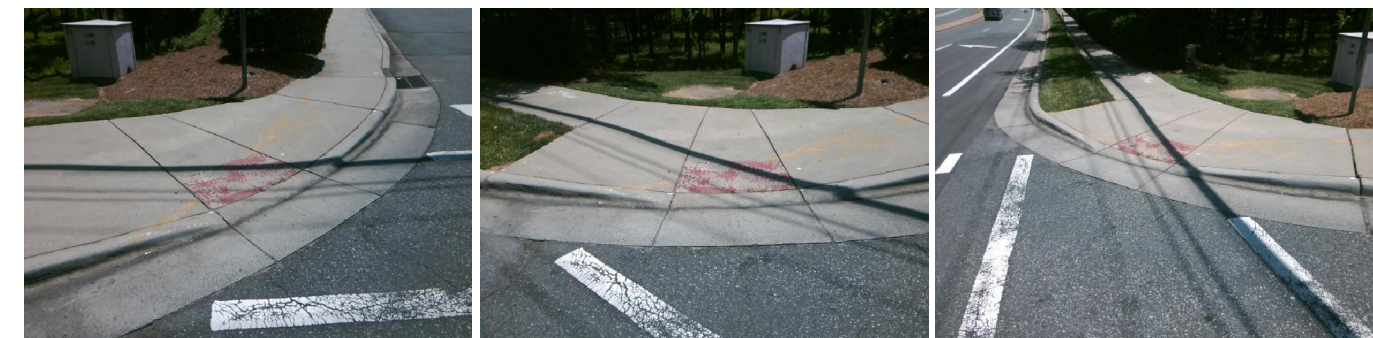
X Walk 1 Direction	To SW		X Walk 2 Direction	N/A
	X Walk 1 Width (in)	71.0		X Walk 2 Width (in)	N/A
	X Walk 1 Slope (%)	3.1		X Walk 2 Slope (%)	N/A
	X Walk 1 X Slope (%)	0.4		X Walk 2 X Slope (%)	N/A
N/A	Ramp inside XWalk1?	Yes	N/A	Ramp inside XWalk2?	N/A
	Road Slope (%)	N/A		Clear Space?	N/A
	Road X Slope (%)	N/A	N/A	Clear Space to XWalk (in)	N/A
			N/A	Any Obstruction?	N/A
				Obstruction Type	N/A
			N/A	Storm Grate/Utility Hazard?	N/A
				Storm Grate/Utility Type	N/A
			Yes	Surface Condition? (G/P)	Good
				Curb Slope (%)	N/A
