Access Compliance Report Public Rights-of-Way (Curb Ramps)

Intersection ID: 10029840 Main Street: KRISLYN_WOODS_PL Cross Street: N/A Location: NE Ramp Type: Directional1 **Overall Compliance: No Severity Score:** ADA ID: C3B5B3723F45 Initial Pass/Fail: Fail 12.5

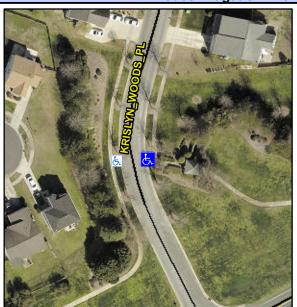
Field Measurements/Component Compliance								
Compliance Description		Data	Compliance Description		Data				
N/A	Ramp Length (in)	80.0	N/A	Grade Break?	N/A				
Yes	Ramp Width (in)	48.0	N/A	Grade Break Slope (%)	0.0				
No	Ramp Slope (%)	9.2	N/A	Grade Break XSlope (%)	0.0				
Yes	Ramp XSlope (%)	0.8							
N/A	Flare Type LT	N/A	N/A	Flare Type RT	N/A				
N/A	Flare Slope LT (%)	N/A	N/A	Flare Slope RT (%)	0.0				
N/A	Flare Traversable LT?	N/A	N/A	Flare Traversable RT?	N/A				
N/A	Landing Length (in)	0.0	N/A	DWS Provided?	N/A				
N/A	Landing Width (in)	0.0	N/A	DWS Contrast?	N/A				
N/A	Landing Slope (%)	0.0	N/A	DWS Length (in)	N/A				
N/A	Landing X Slope (%)	0.0	N/A	DWS Full Width?	N/A				
N/A	Landing Curb? (Y/N)	N/A	N/A	DWS Offset LT (in)	N/A				
N/A	Shared Landing?	N/A	N/A	DWS Offset RT (in)	N/A				
N/A	Gutter Ponding?	0.0	N/A	Gutter Slope (%)	N/A				
N/A	Gutter Lip Ht (in)	0.0	N/A	Gutter X Slope (%)	N/A

Possible Solutions:
The second second	Remove & Replace Entire Ramp.
-	
and an and	
Appendix of	Surveyor Notes:
1	
STATE OF PERSONS ASSESSMENT	N/A
10.00	PROW/ADA:
STATE STATE OF	R304.2.2
STATE OF THE PERSON	
_
