Access Compliance Report

Public Rights-of-Way

(Curb Ramps)

| Intersection ID: 7368 | Main Street: BURCH_DR | Cross Street: DISTRIBUTION_CENTER_DR | Location: SE |

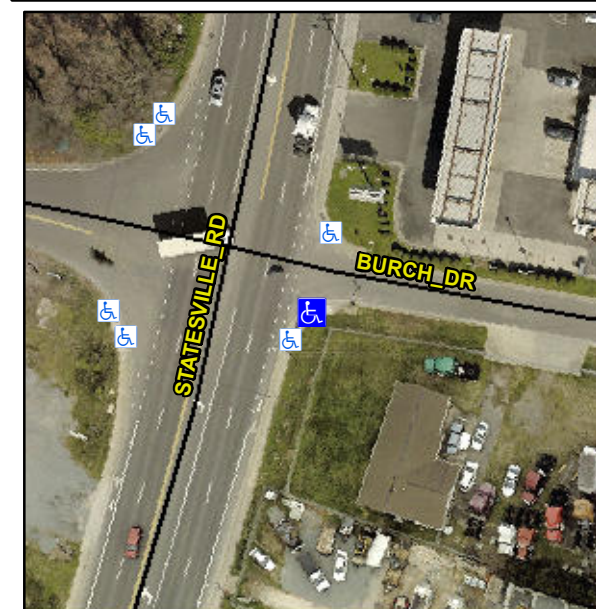
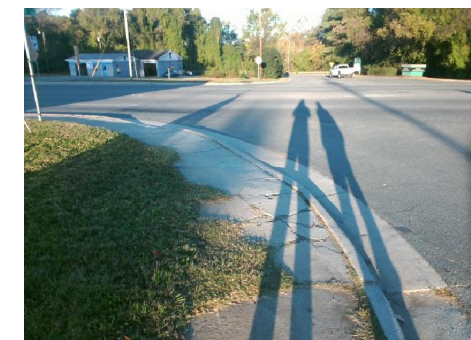
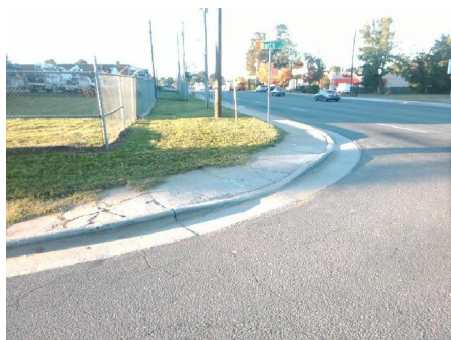
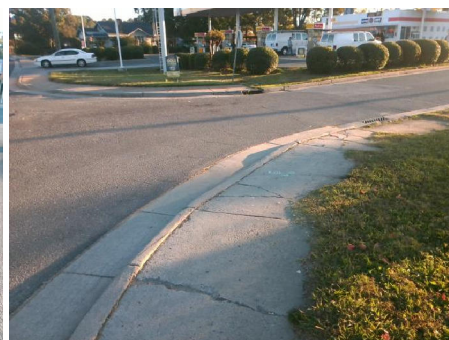
Not Found, R304.5.1, R304.2.2

| Compliance | Description | Data | Compliance | Description | Data |
|---|---|---|---|---|---|
| N/A | Ramp Length (in) | 60.0 | No | Ramp Slope (%) | 10.8 |
| No | Ramp Width (in) | 43.0 | Yes | Ramp XSlope (%) | 0.9 |

Remove & Replace Entire Ramp.
