Access Compliance Report

Public Rights-of-Way

(Curb Ramps)

Intersection ID: 16179	Main Street: HERTFORD_RD	Cross Street: SHERWOOD_AV	Location: NE
ADA ID: C3BFAF1D25F3	Ramp Type: PerpDiag	Initial Pass/Fail: Fail	Overall Compliance: No
		Severity Score: 26.25

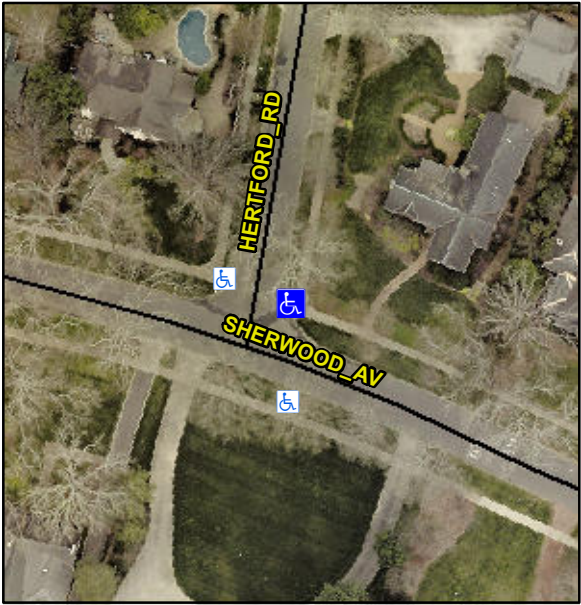
<p>Street 1 Name HERTFORD RD</p> <p>Stop Condition-Street 2 StopSign</p> <p>Street 2 Name SHERWOOD AV</p> <p>Stop Condition-Street 1 None</p>	Possible Solutions:		Compliance	Description	Data
	Remove & Replace Curb Ramp With Two New Directional Ramps or Equivalent.		No	Ramp Length (in)	70.0
			Yes	Ramp Width (in)	60.0
			N/A	Flare Type LT	N/A
			N/A	Flare Slope LT (%)	N/A
			N/A	Flare Traversable LT?	N/A
			N/A	Landing Length (in)	N/A
			N/A	Landing Width (in)	N/A
			N/A	Landing Slope (%)	N/A
			N/A	Landing X Slope (%)	N/A
			N/A	Landing Curb? (Y/N)	N/A
			N/A	Shared Landing?	N/A
			N/A	Gutter Ponding?	N/A
			N/A	Gutter Lip Ht (in)	N/A
			No	Painted X Walk1?	No
				X Walk 1 Direction	To NW
			N/A	X Walk 1 Width (in)	N/A
				X Walk 1 Slope (%)	2.0
				X Walk 1 X Slope (%)	4.1
			N/A	Ramp inside XWalk1?	N/A
<p>Surveyor Notes:</p> <p>N/A</p> <p>PROW/ADA:</p> <p>Not Found, R304.2.2, R304.5.3</p> <p>Total Cost: \$ 3200.00</p>			N/A	Ramp inside XWalk2?	N/A

0.7	Clear Space?	N/A
			0.9	Clear Space to XWalk (in)	N/A
			N/A	Any Obstructions?	N/A
				Obstruction Type	
			N/A	Storm Grate/Utility Hazard?	N/A
				Storm Grate/Utility Type	
			N/A		N/A
			Yes	Surface Condition? (G/P)	Good
