Access Compliance Report

Public Rights-of-Way

(Curb Ramps)

Intersection ID: 13718	Main Street: E_7TH_ST	Cross Street: PARK_DR	Location: S
ADA ID: C3C4D4E3C7BE	Ramp Type: Directional1	Initial Pass/Fail: Fail	Overall Compliance: No
		Severity Score: 12.5

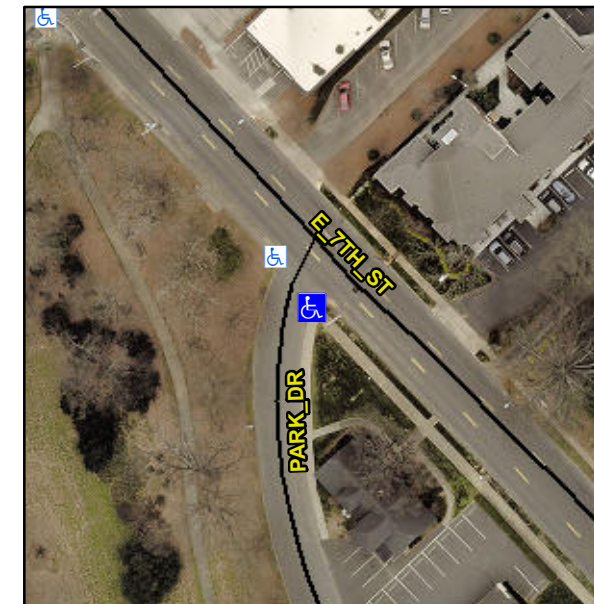
Compliance	Description	Data	Compliance	Description	Data
N/A	Ramp Length (in)	43.0	N/A	Grade Break?	N/A
Yes	Ramp Width (in)	59.0	N/A	Grade Break Slope (%)	0.0
No	Ramp Slope (%)	10.1	N/A	Grade Break XSlope (%)	0.0
Yes	Ramp XSlope (%)	0.5			
N/A	Flare Type LT	N/A	N/A	Flare Type RT	N/A
N/A	Flare Slope LT (%)	N/A	N/A	Flare Slope RT (%)	0.0
N/A	Flare Traversable LT?	N/A	N/A	Flare Traversable RT?	N/A
N/A	Landing Length (in)	0.0	N/A	DWS Provided?	N/A
N/A	Landing Width (in)	0.0	N/A	DWS Contrast?	N/A
N/A	Landing Slope (%)	0.0	N/A	DWS Length (in)	N/A
N/A	Landing X Slope (%)	0.0	N/A	DWS Full Width?	N/A
N/A	Landing Curb? (Y/N)	N/A	N/A	DWS Offset LT (in)	N/A
N/A	Shared Landing?	N/A	N/A	DWS Offset RT (in)	N/A
N/A	Gutter Ponding?	0.0	N/A	Gutter Slope (%)	N/A
N/A	Gutter Lip Ht (in)	0.0	N/A	Gutter X Slope (%)	N/A
N/A	Painted X Walk1?	No		Road Slope (%)	0.1
	X Walk 1 Direction	To NW		Road X Slope (%)	1.3
	X Walk 1 Width (in)	N/A		Clear Space?	N/A

X Walk 1 Slope (%)	0.1	N/A	Clear Space to XWalk (in)	N/A
	X Walk 1 X Slope (%)	1.3	N/A	Storm Grate/Utility Hazard?	N/A
N/A	Ramp inside XWalk1?	N/A		Storm Grate/Utility Type	
N/A	Any Obstructions?	N/A			N/A
	Obstruction Type		Yes	Surface Condition? (G/P)	Good
			N/A	Curb Slope (%)	13.3

Possible Solutions:

Remove & Replace Entire Ramp.

R304.2.2
