# Access Compliance Report

## Public Rights-of-Way

### (Curb Ramps)

Intersection ID: 9202	Main Street: DEWOLFE_ST	Cross Street: GLENWOOD_DR	Location: E
ADA ID: C3D9B9B845A5	Ramp Type: Perp	Initial Pass/Fail: Fail	Overall Compliance: No
Severity Score: 33.75			
Codes/Mitigation Info/Possible Solution		Field Measurements/Component Compliance

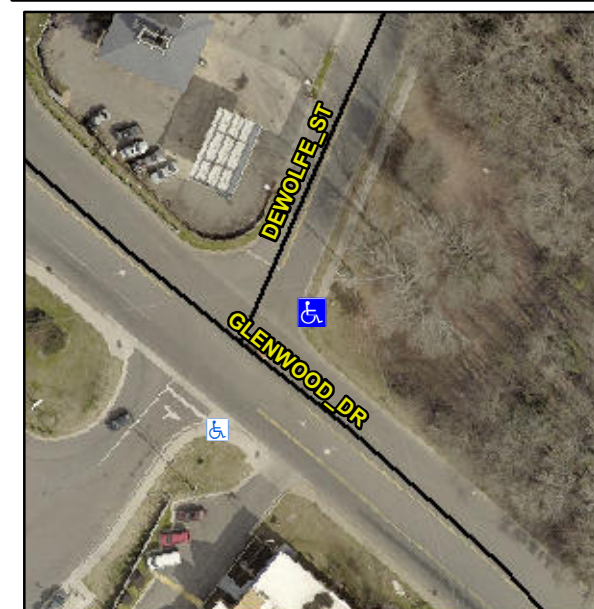
**Not Found, R304.5.1, R304.5.3**

Compliance	Description	Data	Compliance	Description	Data
N/A	Ramp Length (in)	50.0	Yes	Ramp Slope (%)	6.4
No	Ramp Width (in)	47.5	No	Ramp XSlope (%)	7.3
N/A	Flare Type LT	N/A	N/A	Flare Type RT	N/A
N/A	Flare Slope LT (%)	N/A	N/A	Flare Slope RT (%)	N/A
N/A	Flare Traversable LT?	N/A	N/A	Flare Traversable RT?	N/A
N/A	Landing Length (in)	N/A	N/A	DWS Provided?	N/A
N/A	Landing Width (in)	N/A	N/A	DWS Contrast?	N/A
N/A	Landing Slope (%)	N/A	N/A	DWS Length (in)	N/A
N/A	Landing X Slope (%)	N/A	N/A	DWS Full Width?	N/A
N/A	Landing Curb? (Y/N)	N/A	N/A	DWS Offset (in)	N/A
N/A	Shared Landing?	N/A			
N/A	Gutter Ponding?	N/A	N/A	Gutter Slope (%)	N/A
N/A	Gutter Lip Ht (in)	N/A	N/A	Gutter X Slope (%)	N/A
N/A	Painted X Walk1?	No	N/A	Painted X Walk2?	N/A
	X Walk 1 Direction	To SW		X Walk 2 Direction	N/A
N/A	X Walk 1 Width (in)	N/A	N/A	X Walk 2 Width (in)	N/A
	X Walk 1 Slope (%)	6.4		X Walk 2 Slope (%)	N/A
	X Walk 1 X Slope (%)	2.0		X Walk 2 X Slope (%)	N/A

**Remove & Replace Entire Ramp.**

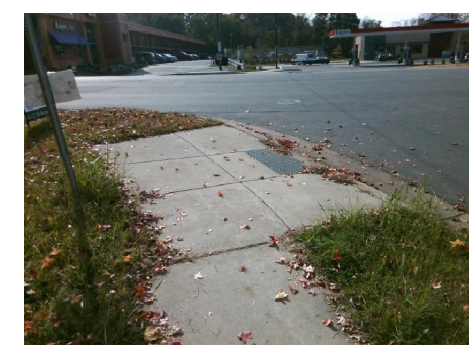
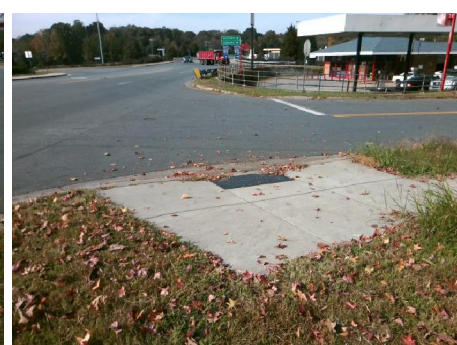
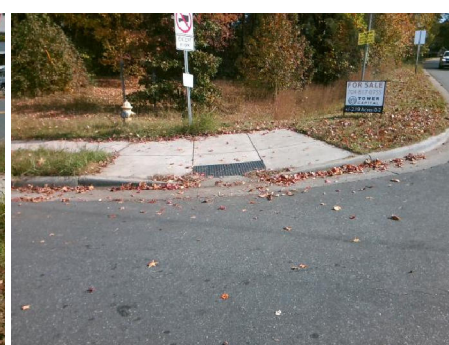
N/A	Ramp inside XWalk1?	N/A	N/A	Ramp inside XWalk2?	N/A
	Road Slope (%)	N/A	N/A	Clear Space?	N/A
	Road X Slope (%)	N/A	N/A	Clear Space to XWalk (in)	N/A
N/A	Any Obstructions?	N/A	N/A	Storm Grate/Utility Hazard?	N/A
	Obstruction Type			Storm Grate/Utility Type	
		N/A			N/A
			Yes	Surface Condition? (G/P)	Good
