# Access Compliance Report

## Public Rights-of-Way (Curb Ramps)

| Intersection ID: 6363 | Main Street: IREDELL_DR | Cross Street: MILHAVEN_LN | Location: NE |
| ADA ID: C3DC07056F26 | Ramp Type: Directional1 | Initial Pass/Fail: Fail | Overall Compliance: No |

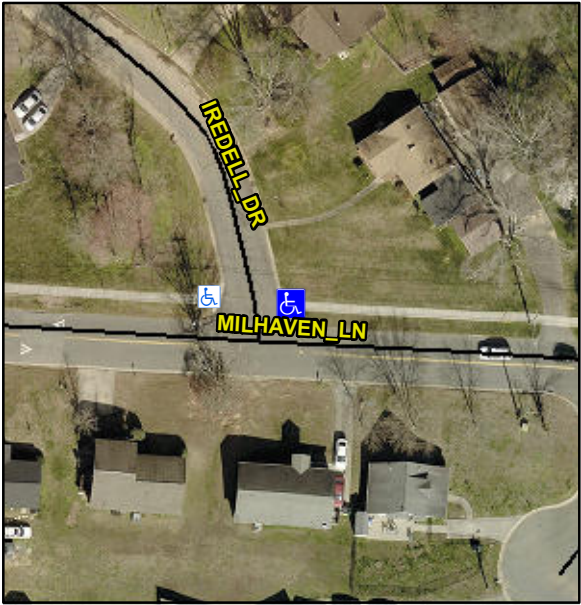
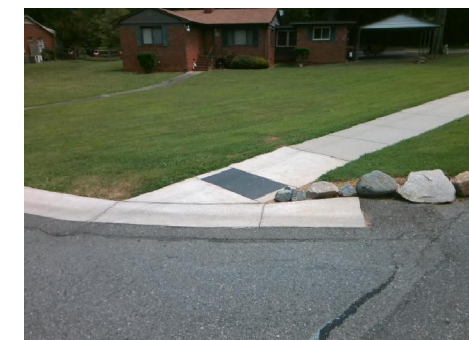
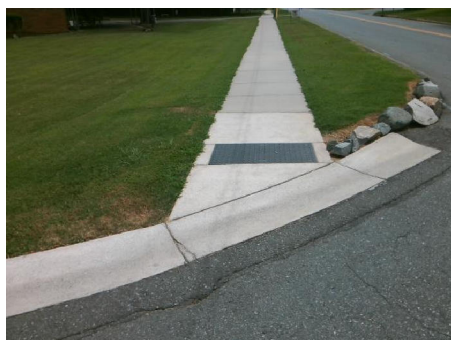
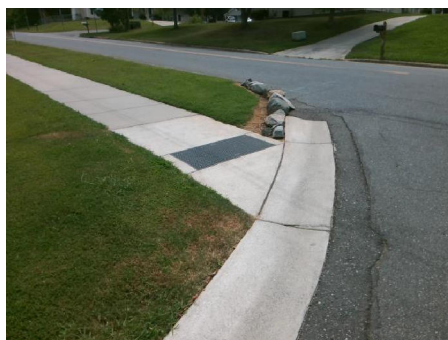
| | | Severity Score: 13.75 | |

| Codes/Mitigation Info/Possible Solution | | | Field Measurements/Component Compliance | | | |
|---|---|--|---|---|---|---|
| | | | No | Ramp Slope (%) | 8.9 | N/A |
| | | | No | Ramp XSlope (%) | 4.0 | N/A |
| <p>Surveyor Notes:</p> <p><b>N/A</b></p> <p>PROW/ADA:</p> <p><b>R304.2.2, R304.5.3</b></p> | | | N/A | Grade Break? | N/A | N/A |

| Codes/Mitigation Info/Possible Solution | | | Field Measurements/Component Compliance | | | |
|---|---|--|---|---|---|---|
| | <b>Remove &amp; Replace Entire Ramp.</b> | | N/A | Ramp Length (in) | 77.0 | N/A |
