# Access Compliance Report

## Public Rights-of-Way

### (Curb Ramps)

Intersection ID: 13007	Main Street: HAWTHORNE_LN	Cross Street: CENTRAL_AV	Location:	SE
ADA ID: C3F96C556CC6	Ramp Type: PerpDiag	Initial Pass/Fail: Fail	Overall Compliance: No	Severity Score: 22.5
Codes/Mitigation Info/Possible Solution		Field Measurements/Component Compliance

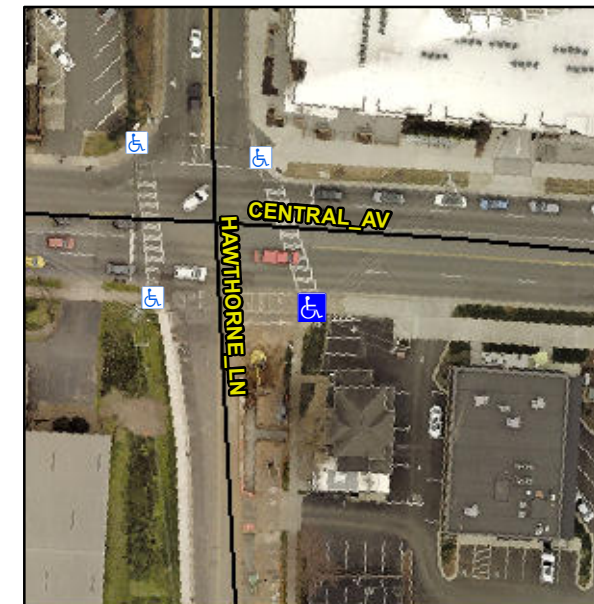
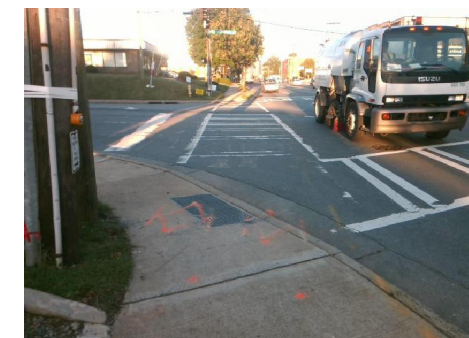
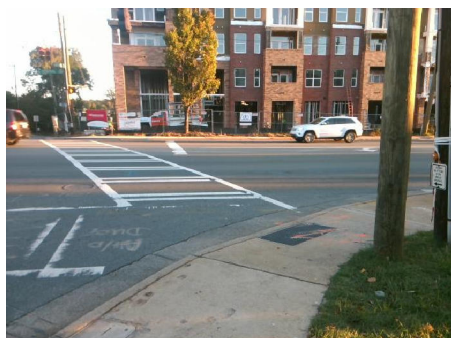
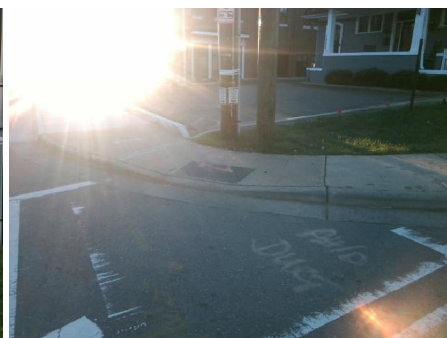
**Not Found, R304.5.1, R304.2.2, R304.5.3**

Compliance	Description	Data	Compliance	Description	Data
N/A	Ramp Length (in)	58.5	No	Ramp Slope (%)	9.7
No	Ramp Width (in)	43.0	No	Ramp XSlope (%)	4.2
N/A	Flare Type LT	N/A	N/A	Flare Type RT	N/A
N/A	Flare Slope LT (%)	N/A	N/A	Flare Slope RT (%)	N/A
N/A	Flare Traversable LT?	N/A	N/A	Flare Traversable RT?	N/A
N/A	Landing Length (in)	N/A	N/A	DWS Provided?	N/A
N/A	Landing Width (in)	N/A	N/A	DWS Contrast?	N/A
N/A	Landing Slope (%)	N/A	N/A	DWS Length (in)	N/A
N/A	Landing X Slope (%)	N/A	N/A	DWS Full Width?	N/A
N/A	Landing Curb? (Y/N)	N/A	N/A	DWS Offset (in)	N/A
N/A	Shared Landing?	N/A			
N/A	Gutter Ponding?	N/A	N/A	Gutter Slope (%)	N/A
N/A	Gutter Lip Ht (in)	N/A	N/A	Gutter X Slope (%)	N/A
N/A	Painted X Walk1?	Yes	N/A	Painted X Walk2?	Yes
	X Walk 1 Direction	To N		X Walk 2 Direction	To W
N/A	X Walk 1 Width (in)	109.0	N/A	X Walk 2 Width (in)	105.0
	X Walk 1 Slope (%)	3.8		X Walk 2 Slope (%)	2.5
	X Walk 1 X Slope (%)	4.4		X Walk 2 X Slope (%)	0.1

N/A	Ramp inside XWalk1?	Yes	N/A	Ramp inside XWalk2?	Yes
	Road Slope (%)	2.8	N/A	Clear Space?	N/A
	Road X Slope (%)	4.2	N/A	Clear Space to XWalk (in)	N/A
N/A	Any Obstructions?	N/A	N/A	Storm Grate/Utility Hazard?	N/A
	Obstruction Type			Storm Grate/Utility Type	
		N/A			N/A
		Yes		Surface Condition? (G/P)	Good

**Remove & Replace Curb Ramp With Two New Directional Ramps or Equivalent.**
