Access Compliance Report

Public Rights-of-Way

(Curb Ramps)

Intersection ID: 10022963	Main Street: CEDAR_WALK_LN	Cross Street: N/A	Location: E
ADA ID: C407B233311B	Ramp Type: PerpDiag	Initial Pass/Fail: Fail	Overall Compliance: No
Severity Score: 22.5			
Codes/Mitigation Info/Possible Solution		Field Measurements/Component Compliance

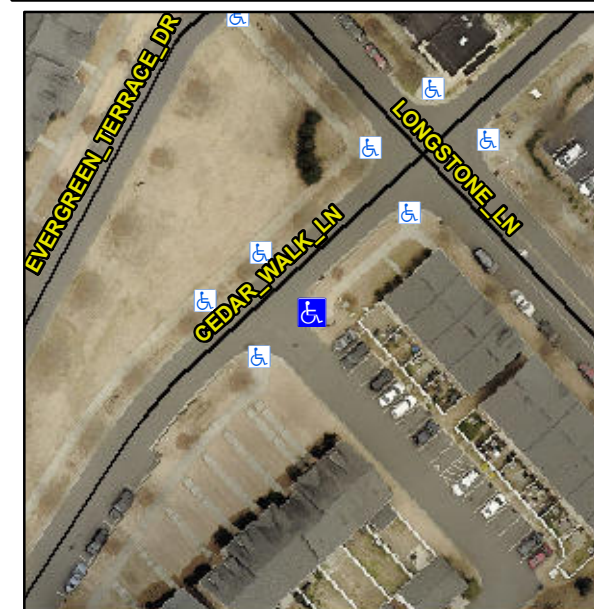
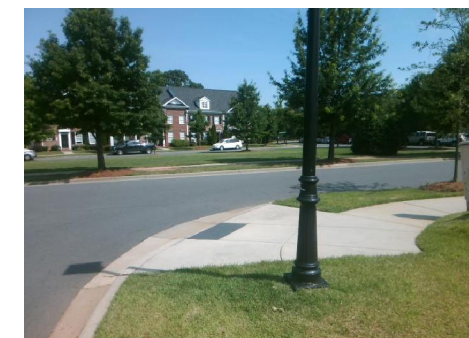
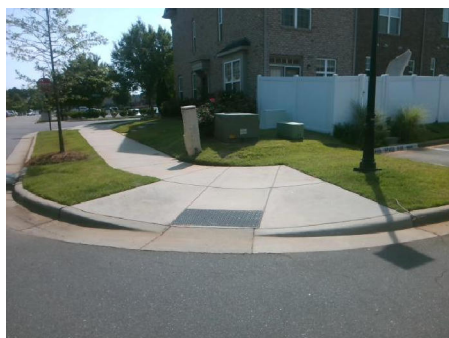
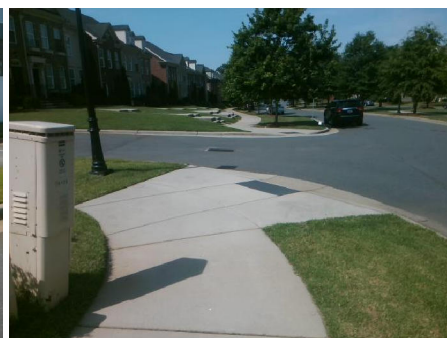
Not Found, R304.5.1, R304.2.2, R304.5.3

Compliance	Description	Data	Compliance	Description	Data
N/A	Ramp Length (in)	144.0	No	Ramp Slope (%)	8.4
No	Ramp Width (in)	46.5	No	Ramp XSlope (%)	4.2
N/A	Flare Type LT	N/A	N/A	Flare Type RT	N/A
N/A	Flare Slope LT (%)	N/A	N/A	Flare Slope RT (%)	N/A
N/A	Flare Traversable LT?	N/A	N/A	Flare Traversable RT?	N/A
N/A	Landing Length (in)	N/A	N/A	DWS Provided?	N/A
N/A	Landing Width (in)	N/A	N/A	DWS Contrast?	N/A
N/A	Landing Slope (%)	N/A	N/A	DWS Length (in)	N/A
N/A	Landing X Slope (%)	N/A	N/A	DWS Full Width?	N/A
N/A	Landing Curb? (Y/N)	N/A	N/A	DWS Offset (in)	N/A
N/A	Shared Landing?	N/A			
N/A	Gutter Ponding?	N/A	N/A	Gutter Slope (%)	N/A
N/A	Gutter Lip Ht (in)	N/A	N/A	Gutter X Slope (%)	N/A
N/A	Painted X Walk1?	No	N/A	Painted X Walk2?	No
	X Walk 1 Direction	To NW		X Walk 2 Direction	To SW
N/A	X Walk 1 Width (in)	N/A	N/A	X Walk 2 Width (in)	N/A
	X Walk 1 Slope (%)	1.5		X Walk 2 Slope (%)	2.0
	X Walk 1 X Slope (%)	1.2		X Walk 2 X Slope (%)	1.1

N/A	Ramp inside XWalk1?	N/A	N/A	Ramp inside XWalk2?	N/A
	Road Slope (%)	0.6	N/A	Clear Space?	N/A
	Road X Slope (%)	2.0	N/A	Clear Space to XWalk (in)	N/A
N/A	Any Obstructions?	N/A	N/A	Storm Grate/Utility Hazard?	N/A
	Obstruction Type			Storm Grate/Utility Type	
		N/A			N/A
			Yes	Surface Condition? (G/P)	Good

Remove & Replace Curb Ramp With Two New Directional Ramps or Equivalent.
