Intersection ID: 15989	Main Street: S_TRYON_ST	Cross Street: YORKSHIRE_DR	Location:	NE
ADA ID: C40F54398B1A	Ramp Type: PerpDiag	Initial Pass/Fail: Fail	Overall Compliance: No	Severity Score: 22.5

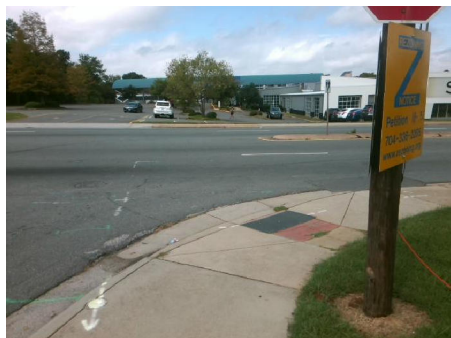
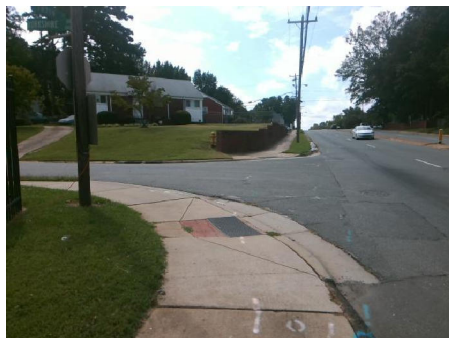
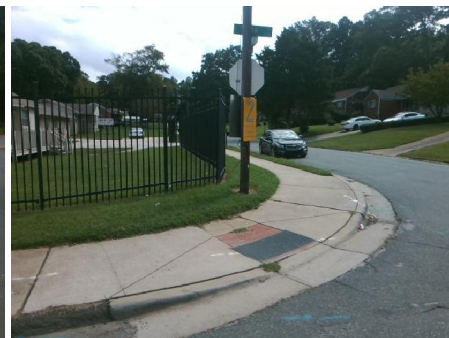
Street 1 Name	S TRYON ST
Stop Condition-Street 2	None
Street 2 Name	YORKSHIRE DR
Stop Condition-Street 1	StopSign
