# Access Compliance Report

## Public Rights-of-Way

### (Curb Ramps)

| Intersection ID: 10990 | Main Street: BARRINGTON_DR | Cross Street: LANECREST_DR | Location: SW |

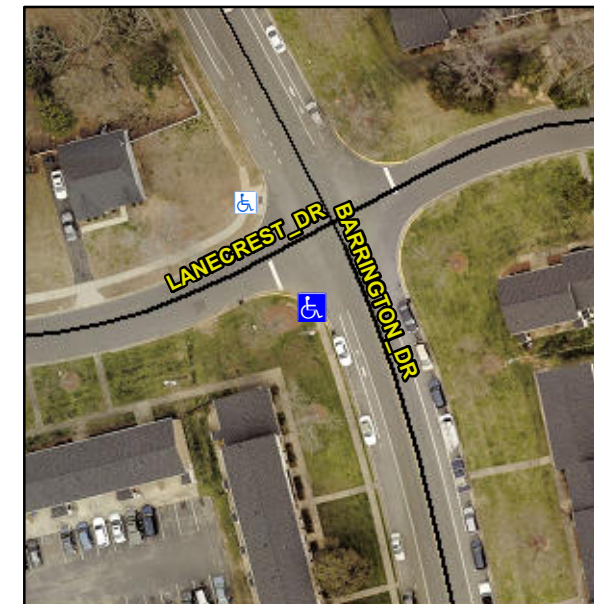
Surveyor Notes:

**LNDG LIP 1.0"**

PROW/ADA:

**R304.5.1**

| Compliance | Description | Data | Compliance | Description | Data |
|---|---|---|---|---|---|
| No | Ramp Width (in) | 29.5 | N/A | Grade Break Slope (%) | 0.0 |

Possible Solutions:

**Remove & Replace Entire Ramp.**

Total Cost:

\$ 1600.00
