# Access Compliance Report

## Public Rights-of-Way

### (Curb Ramps)

Intersection ID: 21826	Main Street: RENFROW_LN	Cross Street: RICHARD_BARRY_DR	Location: NW
ADA ID: C417F7BEE402	Ramp Type: Perp	Initial Pass/Fail: Fail	Overall Compliance: No
Severity Score: 37.5			
Codes/Mitigation Info/Possible Solution		Field Measurements/Component Compliance

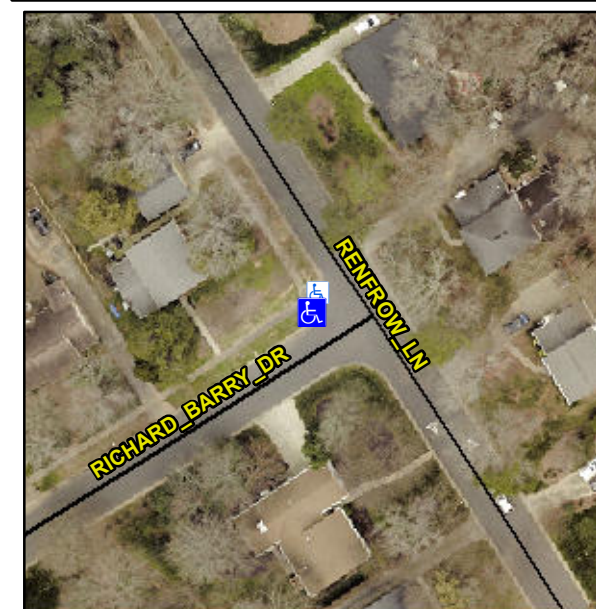
Compliance	Description	Data	Compliance	Description	Data
N/A	Ramp Length (in)	92.0	No	Ramp Slope (%)	10.9
Yes	Ramp Width (in)	48.0	No	Ramp XSlope (%)	7.4
N/A	Flare Type LT	N/A	N/A	Flare Type RT	N/A
N/A	Flare Slope LT (%)	N/A	N/A	Flare Slope RT (%)	N/A
N/A	Flare Traversable LT?	N/A	N/A	Flare Traversable RT?	N/A
N/A	Landing Length (in)	N/A	N/A	DWS Provided?	N/A
N/A	Landing Width (in)	N/A	N/A	DWS Contrast?	N/A
N/A	Landing Slope (%)	N/A	N/A	DWS Length (in)	N/A
N/A	Landing X Slope (%)	N/A	N/A	DWS Full Width?	N/A
N/A	Landing Curb? (Y/N)	N/A	N/A	DWS Offset (in)	N/A
N/A	Shared Landing?	N/A			
N/A	Gutter Ponding?	N/A	N/A	Gutter Slope (%)	N/A
N/A	Gutter Lip Ht (in)	N/A	N/A	Gutter X Slope (%)	N/A
N/A	Painted X Walk1?	No	N/A	Painted X Walk2?	N/A
	X Walk 1 Direction	To SE		X Walk 2 Direction	N/A
N/A	X Walk 1 Width (in)	N/A	N/A	X Walk 2 Width (in)	N/A
	X Walk 1 Slope (%)	0.6		X Walk 2 Slope (%)	N/A
	X Walk 1 X Slope (%)	4.3		X Walk 2 X Slope (%)	N/A

N/A	Ramp inside XWalk1?	N/A	N/A	Ramp inside XWalk2?	N/A
	Road Slope (%)	N/A	N/A	Clear Space?	N/A
	Road X Slope (%)	N/A	N/A	Clear Space to XWalk (in)	N/A
N/A	Any Obstructions?	N/A	N/A	Storm Grate/Utility Hazard?	N/A
	Obstruction Type			Storm Grate/Utility Type	
		N/A			N/A
			Yes	Surface Condition? (G/P)	Good

**Remove & Replace Entire Ramp.**

**R304.2.2, R304.5.3**

Total Cost: \$ 1850.00
