Access Compliance Report Public Rights-of-Way (Curb Ramps)

Intersection ID: 11098	Main Street: GESCO_ST			Cross	Cross Street: TUCKASEEGEE_RD			Location: E		
ADA ID: C41D94154045	Ramp Type: Perp			Initial	Initial Pass/Fail: Fail Overall Complian			nce: No Severity Score: 21.25		
Codes/Mitigation Info/Possible Solution				Field Measurements/Component Compliance						
	CONC DA	Possible Solutions:			Compliance Description			Data Compliance Description		
1 Mar 1 Martin	NO.L	Remove & Replace Entire	Ramp) .	N/A	Ramp Length (in)	60.0	No	Ramp Slope (%)	9.4

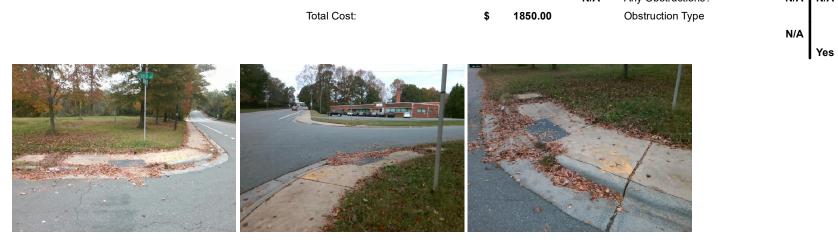
•	•		No	Ramp Width (in)	38.0	Yes	Ramp XSlope (%)	0.3
1 a					N/A	Flare Type LT	N/A	N/A	Flare Type RT	N/A
	121	2			N/A	Flare Slope LT (%)	N/A	N/A	Flare Slope RT (%)	N/A
Pa la	an the second				N/A	Flare Traversable LT?	N/A	N/A	Flare Traversable RT?	N/A
1 ko					N/A	Landing Length (in)	N/A	N/A	DWS Provided?	N/A
CARE 1 CAR	The same is	Surveyor Notes:			N/A	Landing Width (in)	N/A	N/A	DWS Contrast?	N/A
	and the second	N/A			N/A	Landing Slope (%)	N/A	N/A	DWS Length (in)	N/A

s Surface Condition? (G/P)

Good
